**EirGrid
Enforcement Notice
LAOIS KILKENNY
REINFORCEMENT PROJECT -
COOLNABACKY 400 kV SUBSTATION**

Report to assess the impact of the unauthorized development on the Aquifer at Coolnabacky Construction site

PROJECT: **LAOIS KILKENNY REINFORCEMENT PROJECT - COOLNABACKY SUBSTATION** **400kV**

CLIENT: **EirGrid Plc**

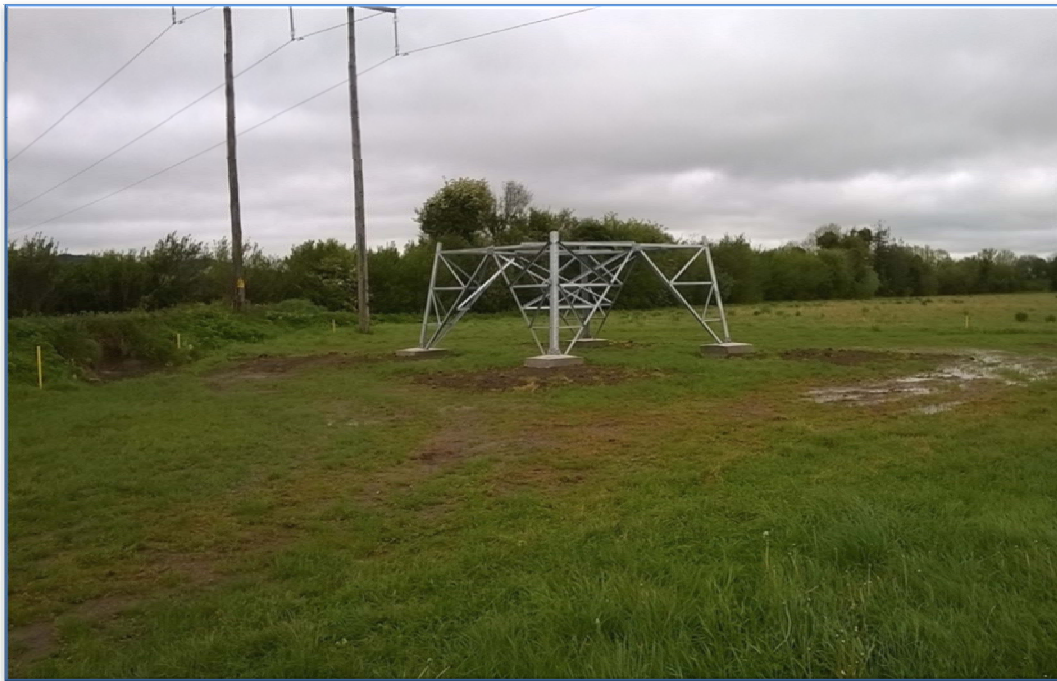
Photograph 1 Tower foundation following unauthorized works.

A partially constructed tower and completed foundation pads were in place at one tower location (See Photograph 1). Material stored on site comprised raw materials including steelwork is shown in Photograph 2. The dry drainage ditch crossing and site access are shown in Photograph 3. Based on site walkover no changes to the overall site topography or runoff patterns occur as a result of the dry drain installation. No impermeable surfaces were constructed for the site access. There was no evidence of siltation of the nearby drains occurring as a result of the unauthorised works. Natural stones and soil were stored in a neat stockpile on site and partially revegetated. Areas identified as tower bases for the remaining towers on site were left indistinguishable from the adjoining areas.

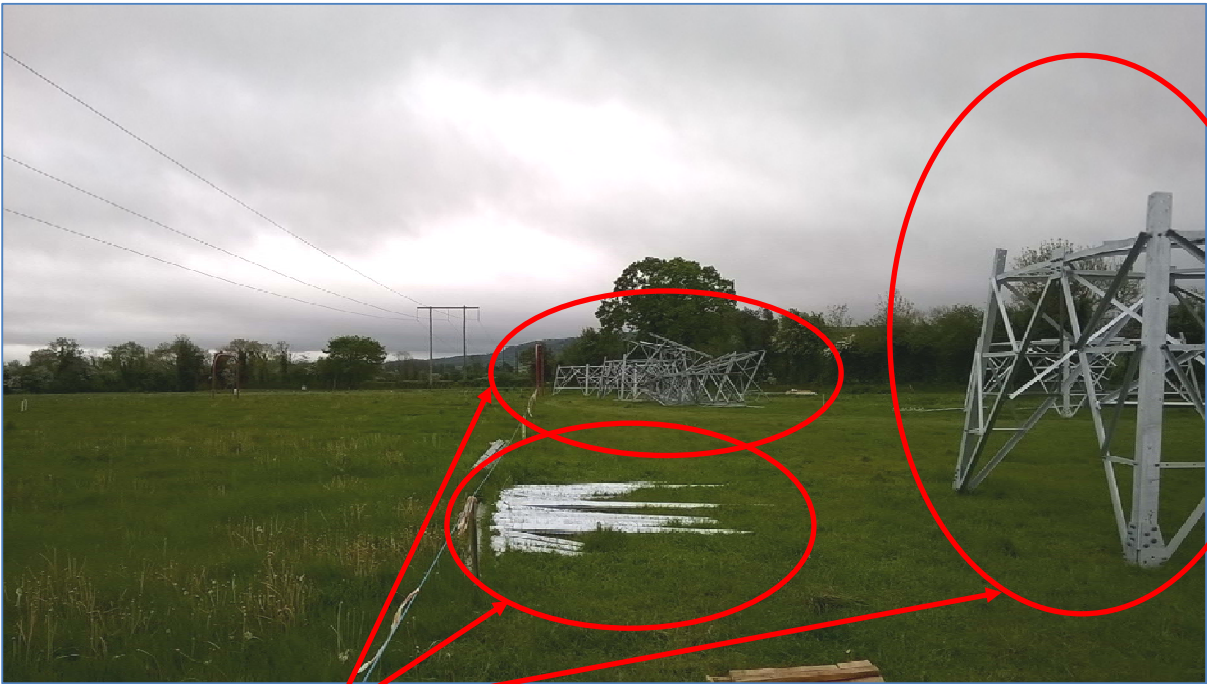
Photograph 2 Materials retained on site following unauthorized works.

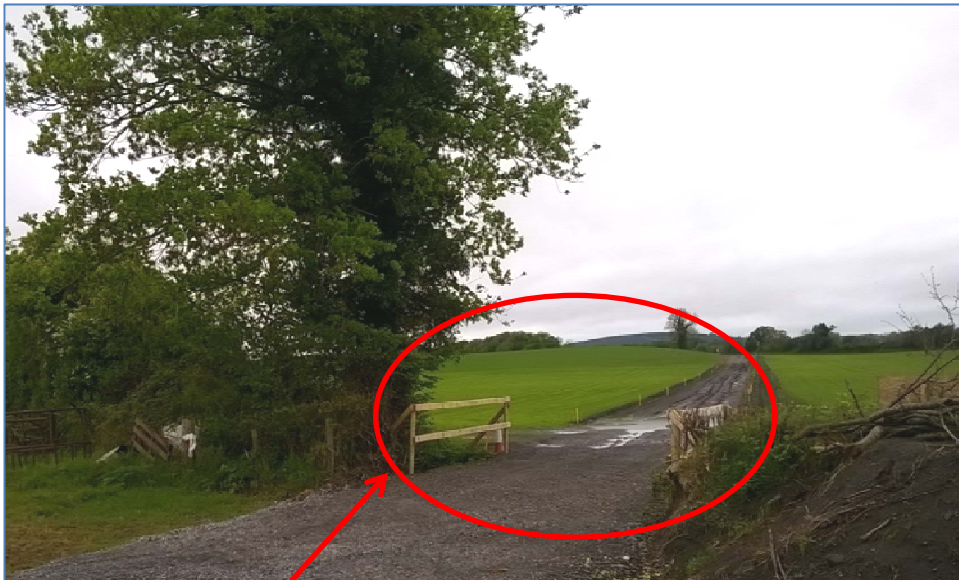
Photograph 3 Dry drain crossing following unauthorized works.

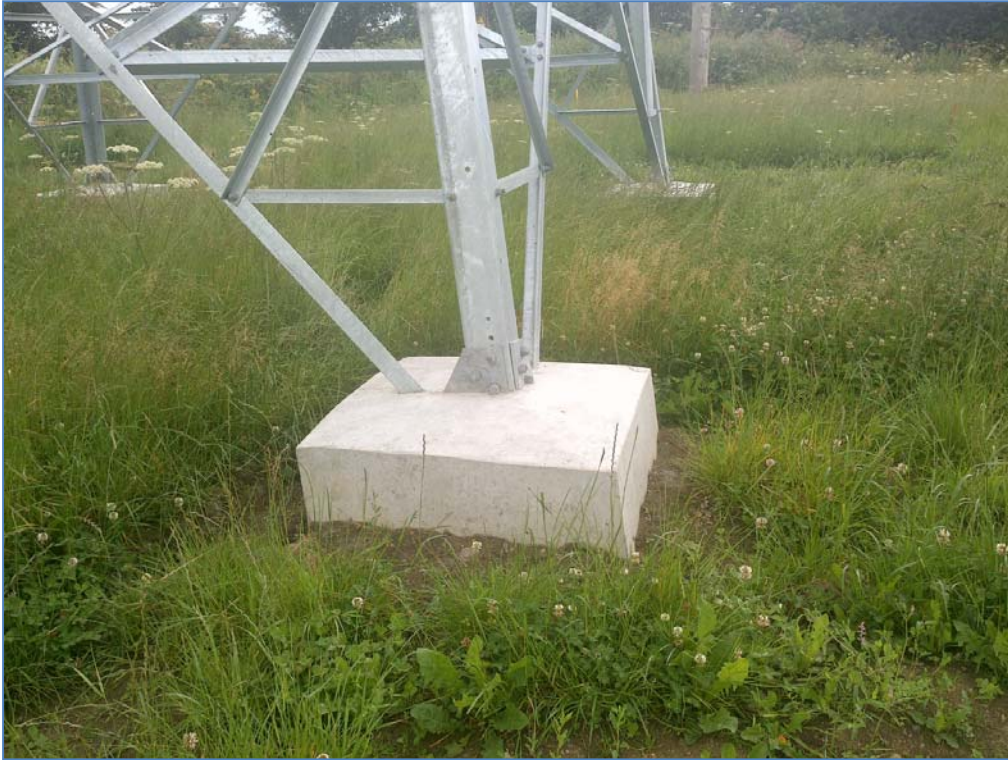
Photograph 4 Tower legs pre-removal.

When the work started the foundation caps, as shown in Photograph 4, were removed. This allowed the tower steelwork to be disassembled. Once the steelwork sections were removed the topsoil and subsoil surrounding each tower leg was excavated to approximately 2 m depth. This enabled the concrete to be broken down using a rock breaker. This is shown in Photographs 5 - 7 where concrete is broken into manageable sized pieces for removal.

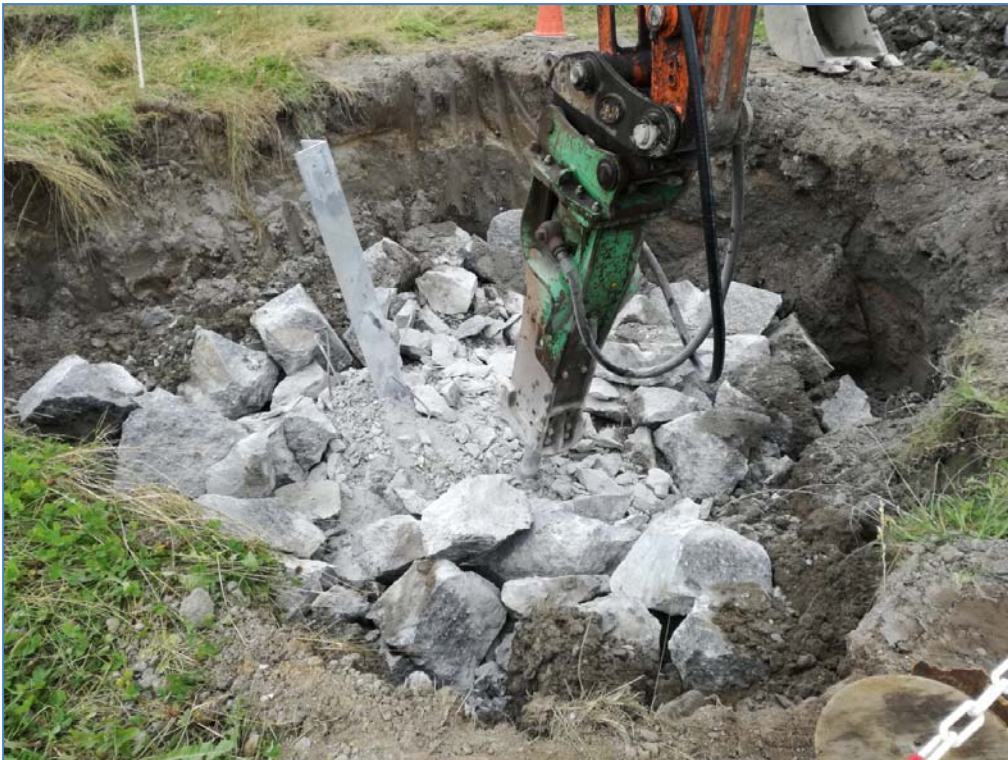
Photograph 5 Tower leg removal.

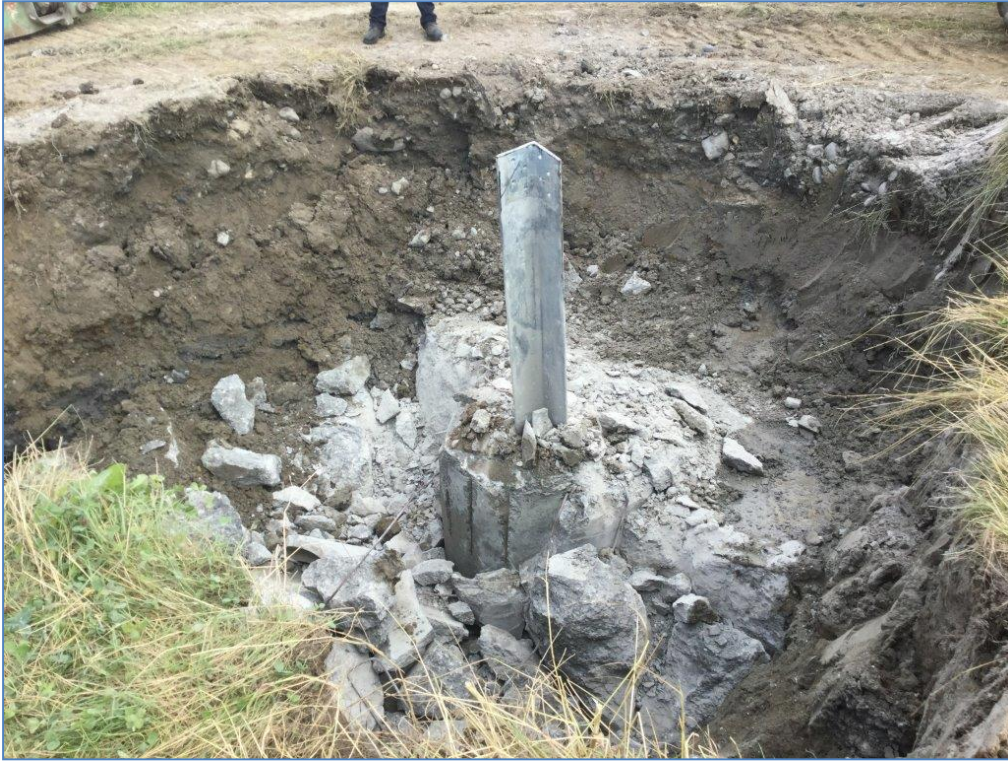
Photograph 6 Tower leg removal.

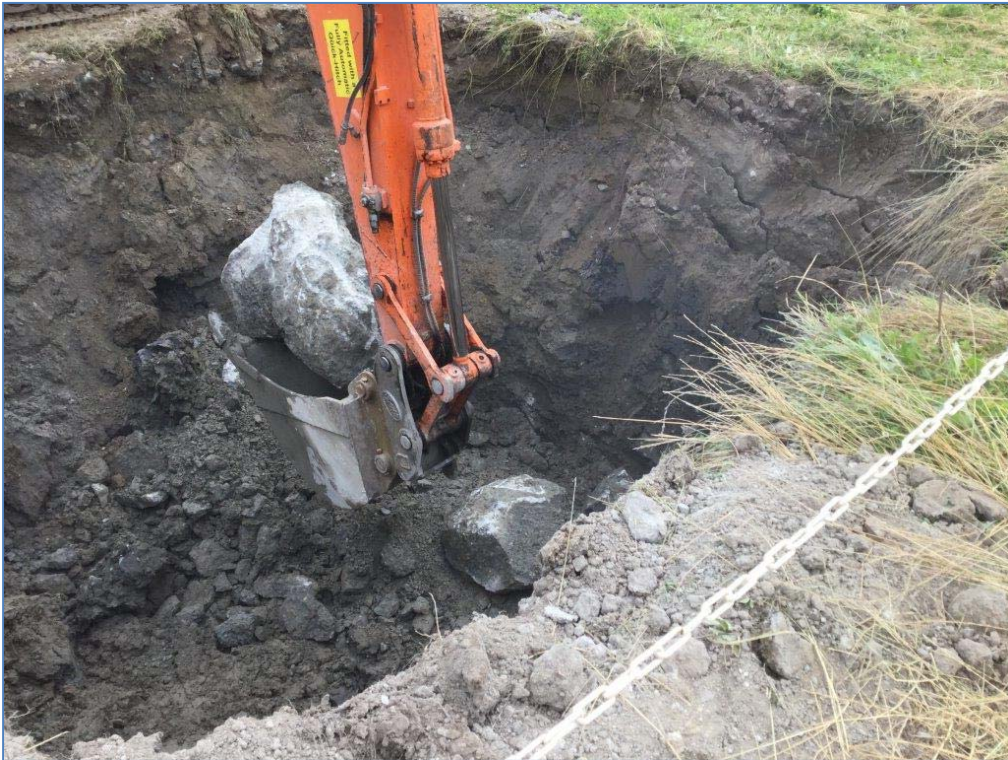
Photograph 7 Tower leg removal.

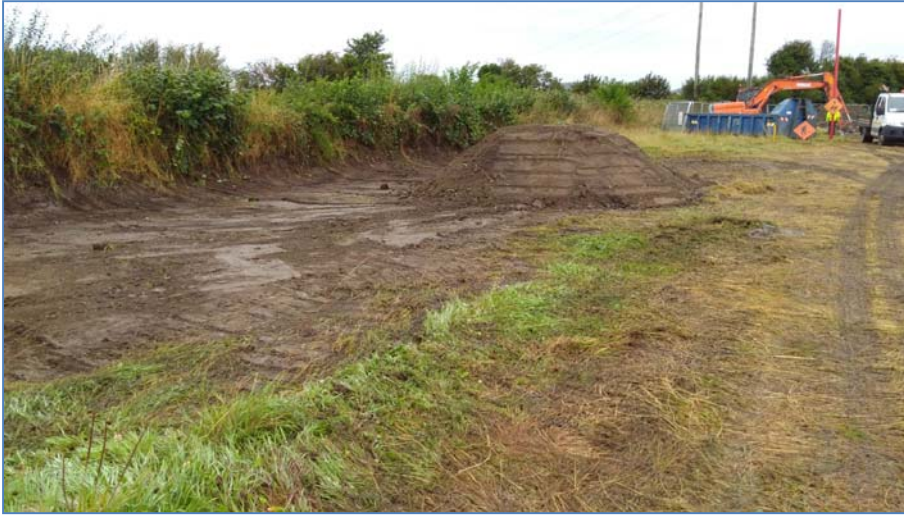
Photograph 8 Stored topsoil to be reinstated.

When all the concrete for that leg was removed using an excavator this was stored separately for removal. The stored subsoil and topsoil was used to reinstate the area where the foundation was removed. Photograph 8 shows the stored topsoil and Photograph 9 shows the subsoil being used for reinstatement. This process was completed for the remaining three tower legs and the area following restoration is shown in Photograph 10.

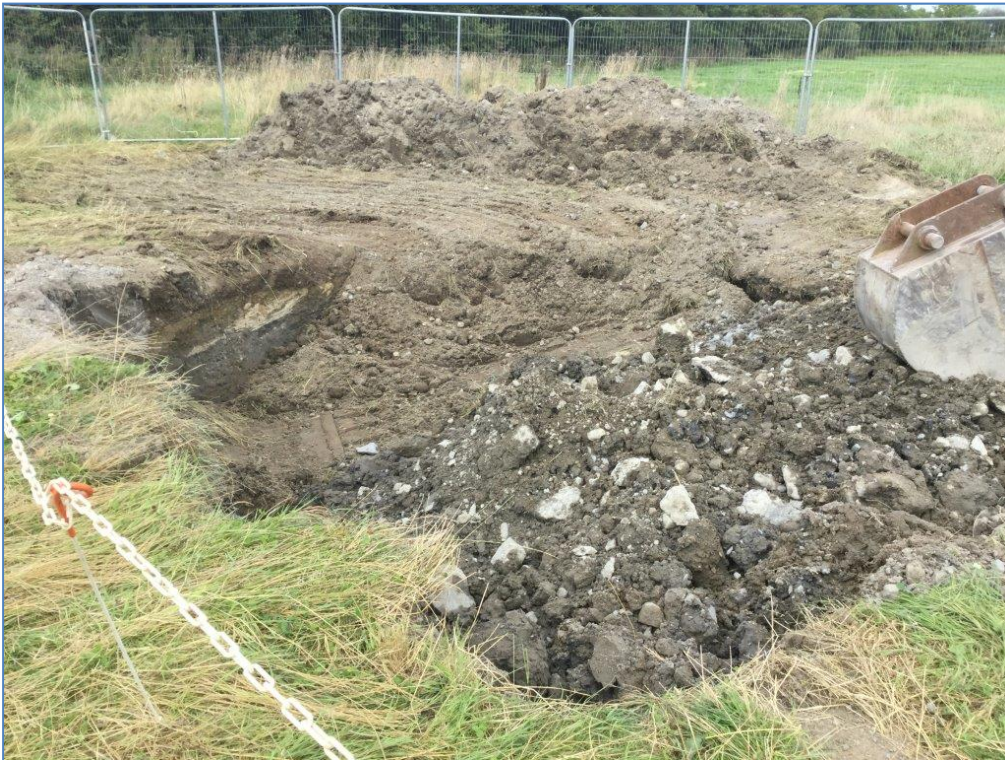
Photograph 9 Tower leg reinstatement with subsoil.

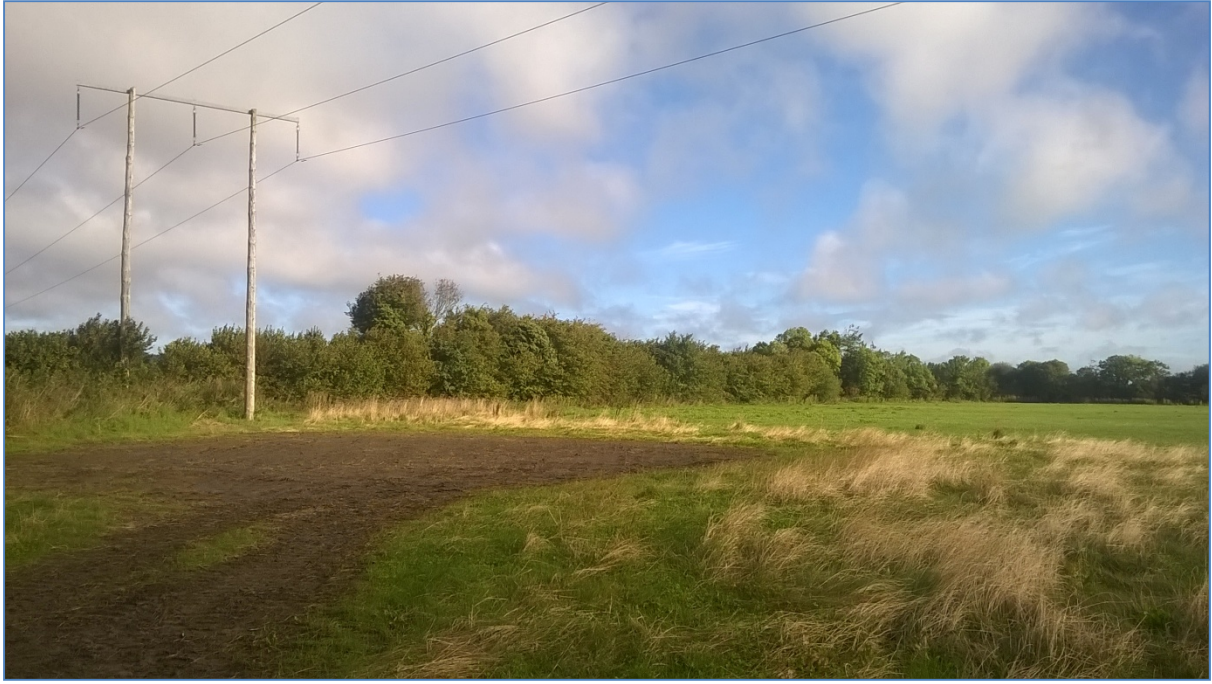
Photograph 10 Site location following restoration works.

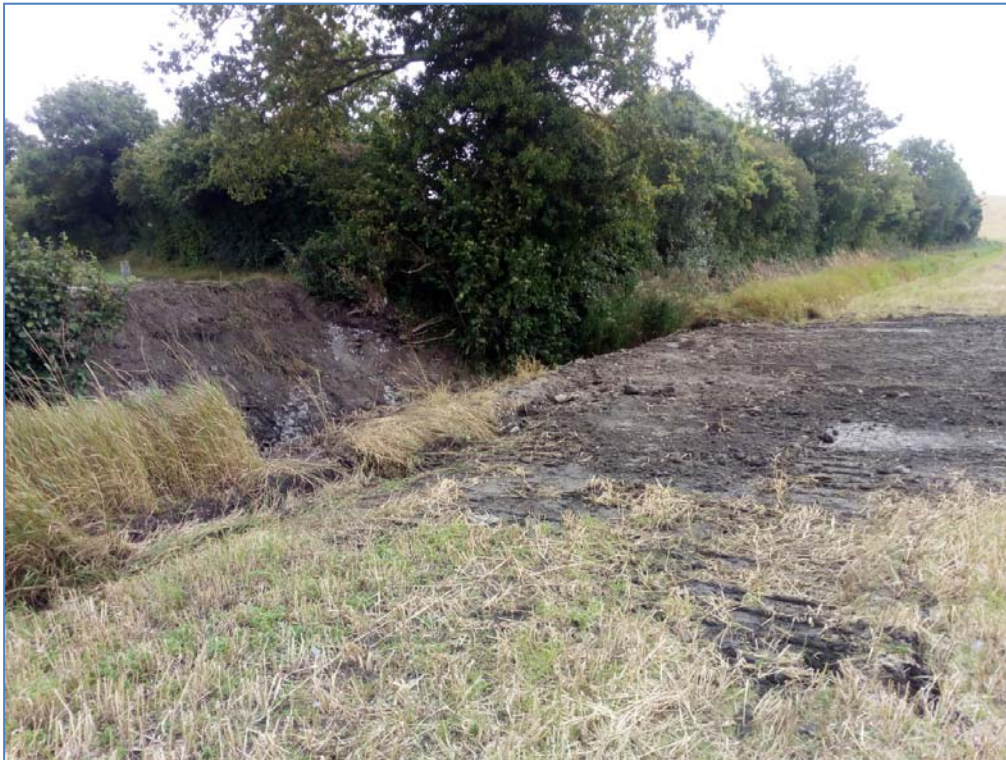
Photograph 11 Reinstated Drain and Dry Bank following removal of drain crossing.

All overhead line materials that were stored on the site were removed to the ESB Networks compound. Following the completion of the site works the drain crossing was removed and restored as shown in Photograph 11. A number of Photographs are included below of the restoration works undertaken by Reach Active.
