Photographic Survey + Drawings

Vacant Structure to be Demolished

Junction of Derry Road and N77

Durrow, Co. Laois

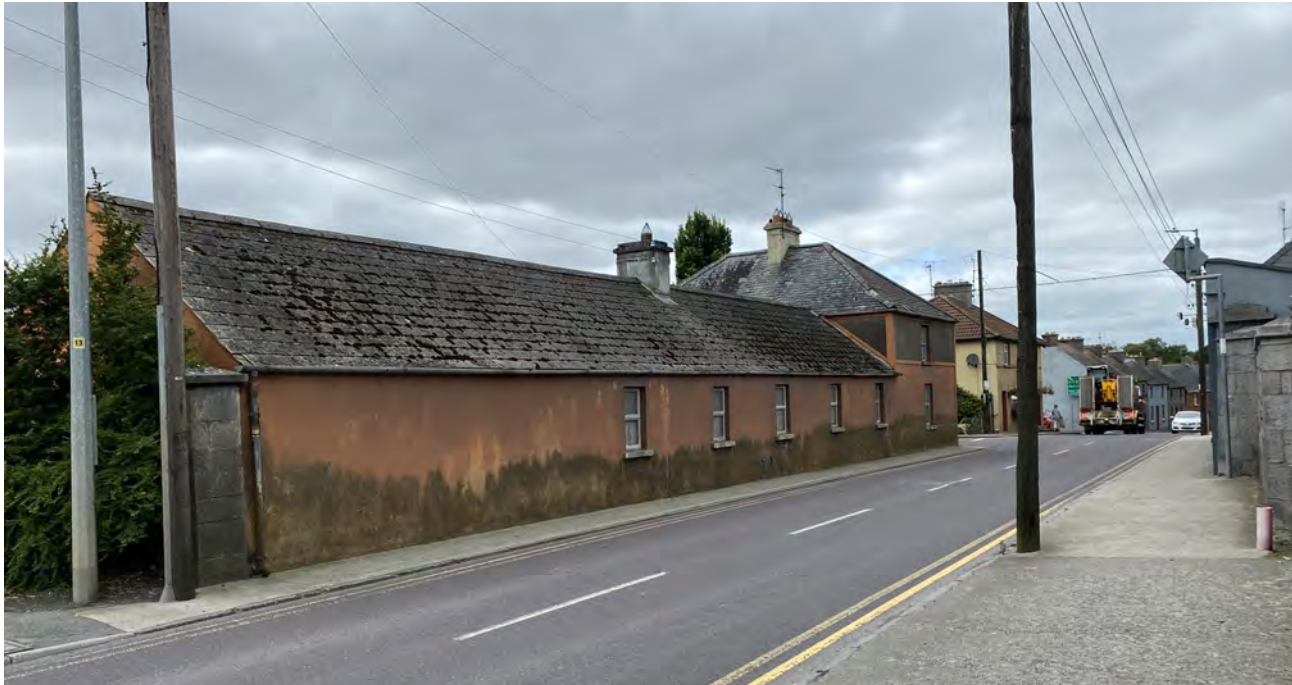
North Elevation - Facing N77

Dwelling location very close to carriageway - does not allow for sufficient footpath width along main street.

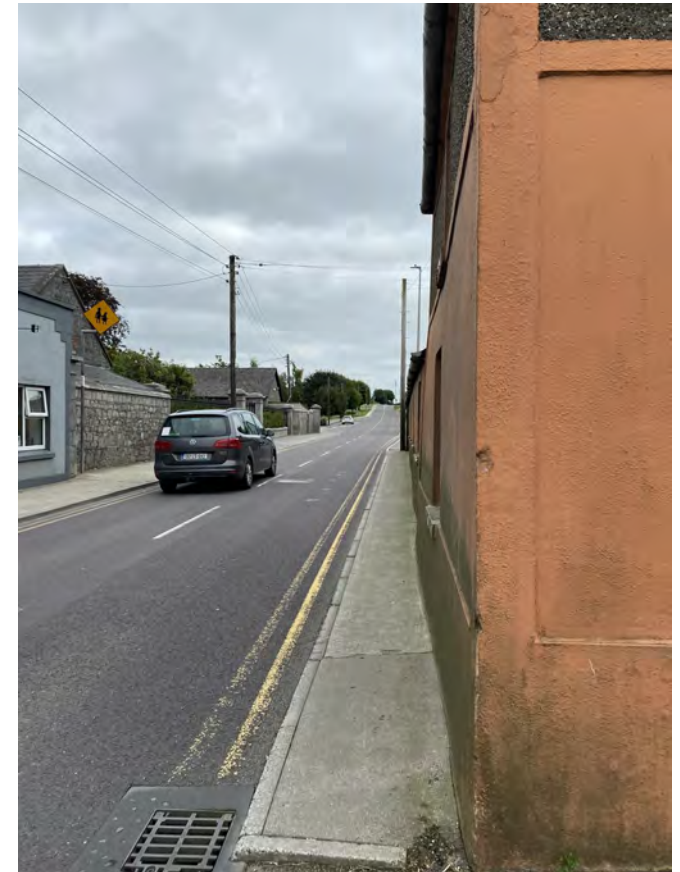
Constant flow of heavy traffic passing very close to the structure

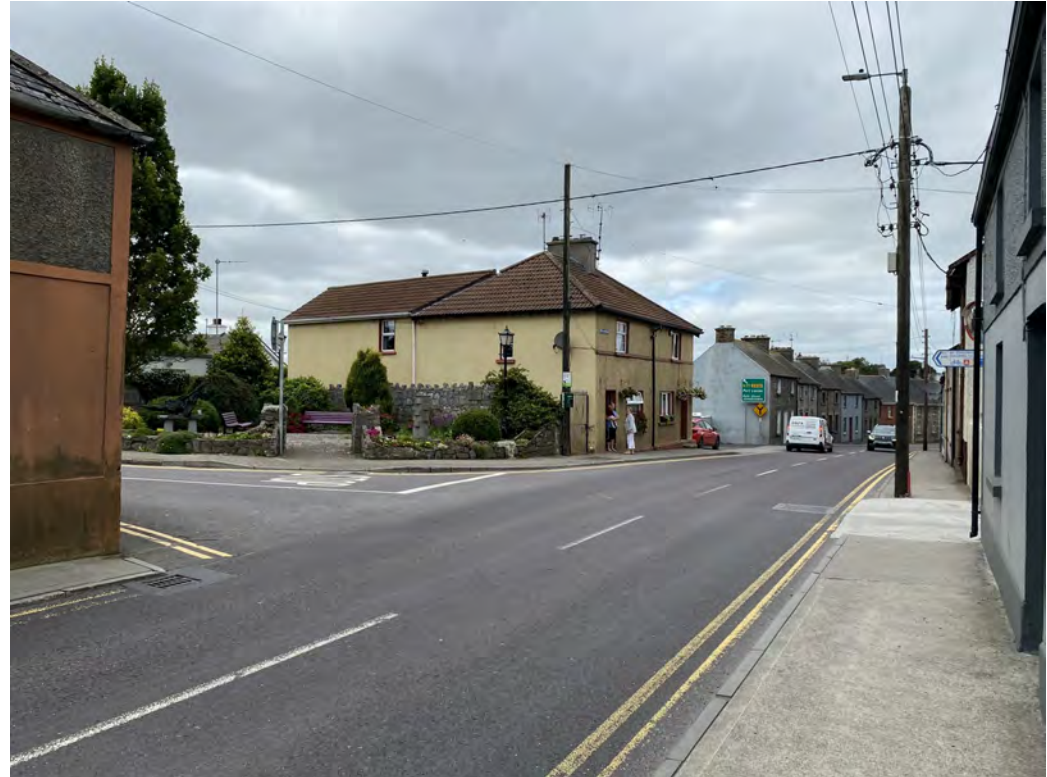
View of Building set back at other side of junction. Continuous street terrace commences after this house.

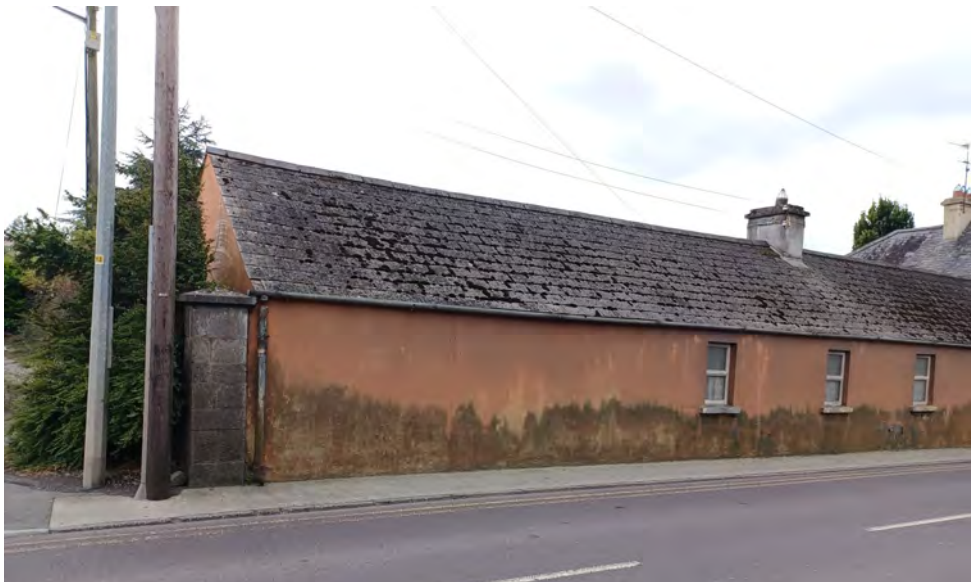
Dwelling location is very close to carriageway and does not allow for sufficient footpath width.

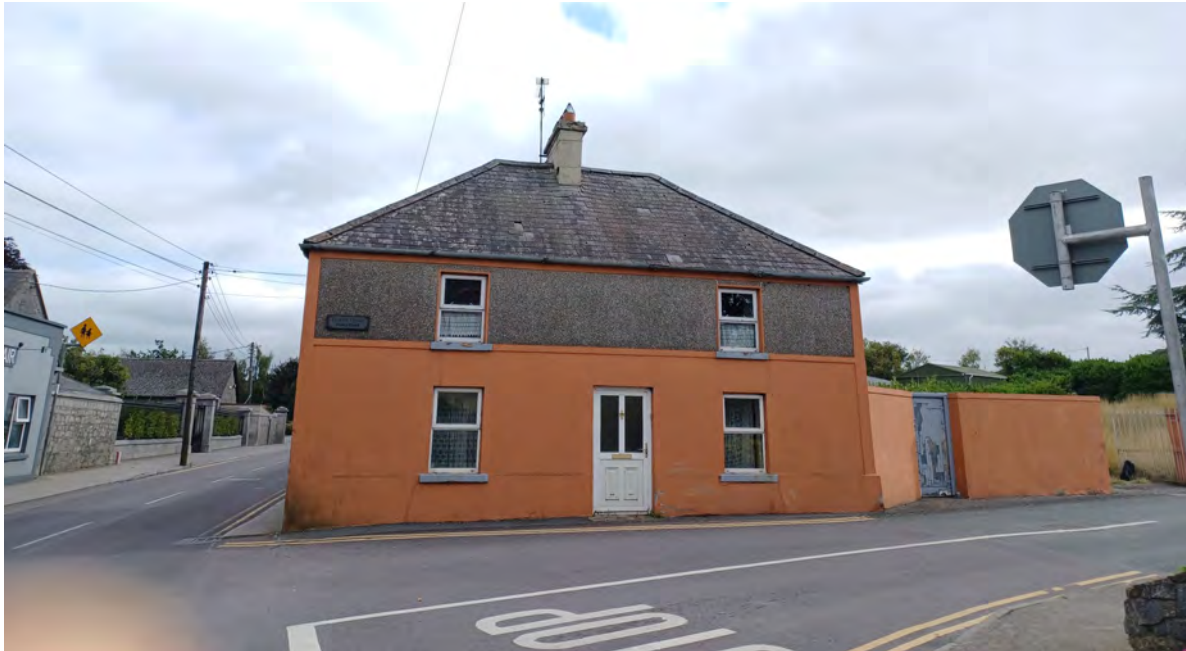
Dwelling location is very close to carriageway and does not allow for footpath width. Dangerous access to dwelling
