Summary and Risk Impact Assessment of Historic Ground Investigations

Coolnabacky, Timahoe, Co. Laois

Date: 11th September 2023

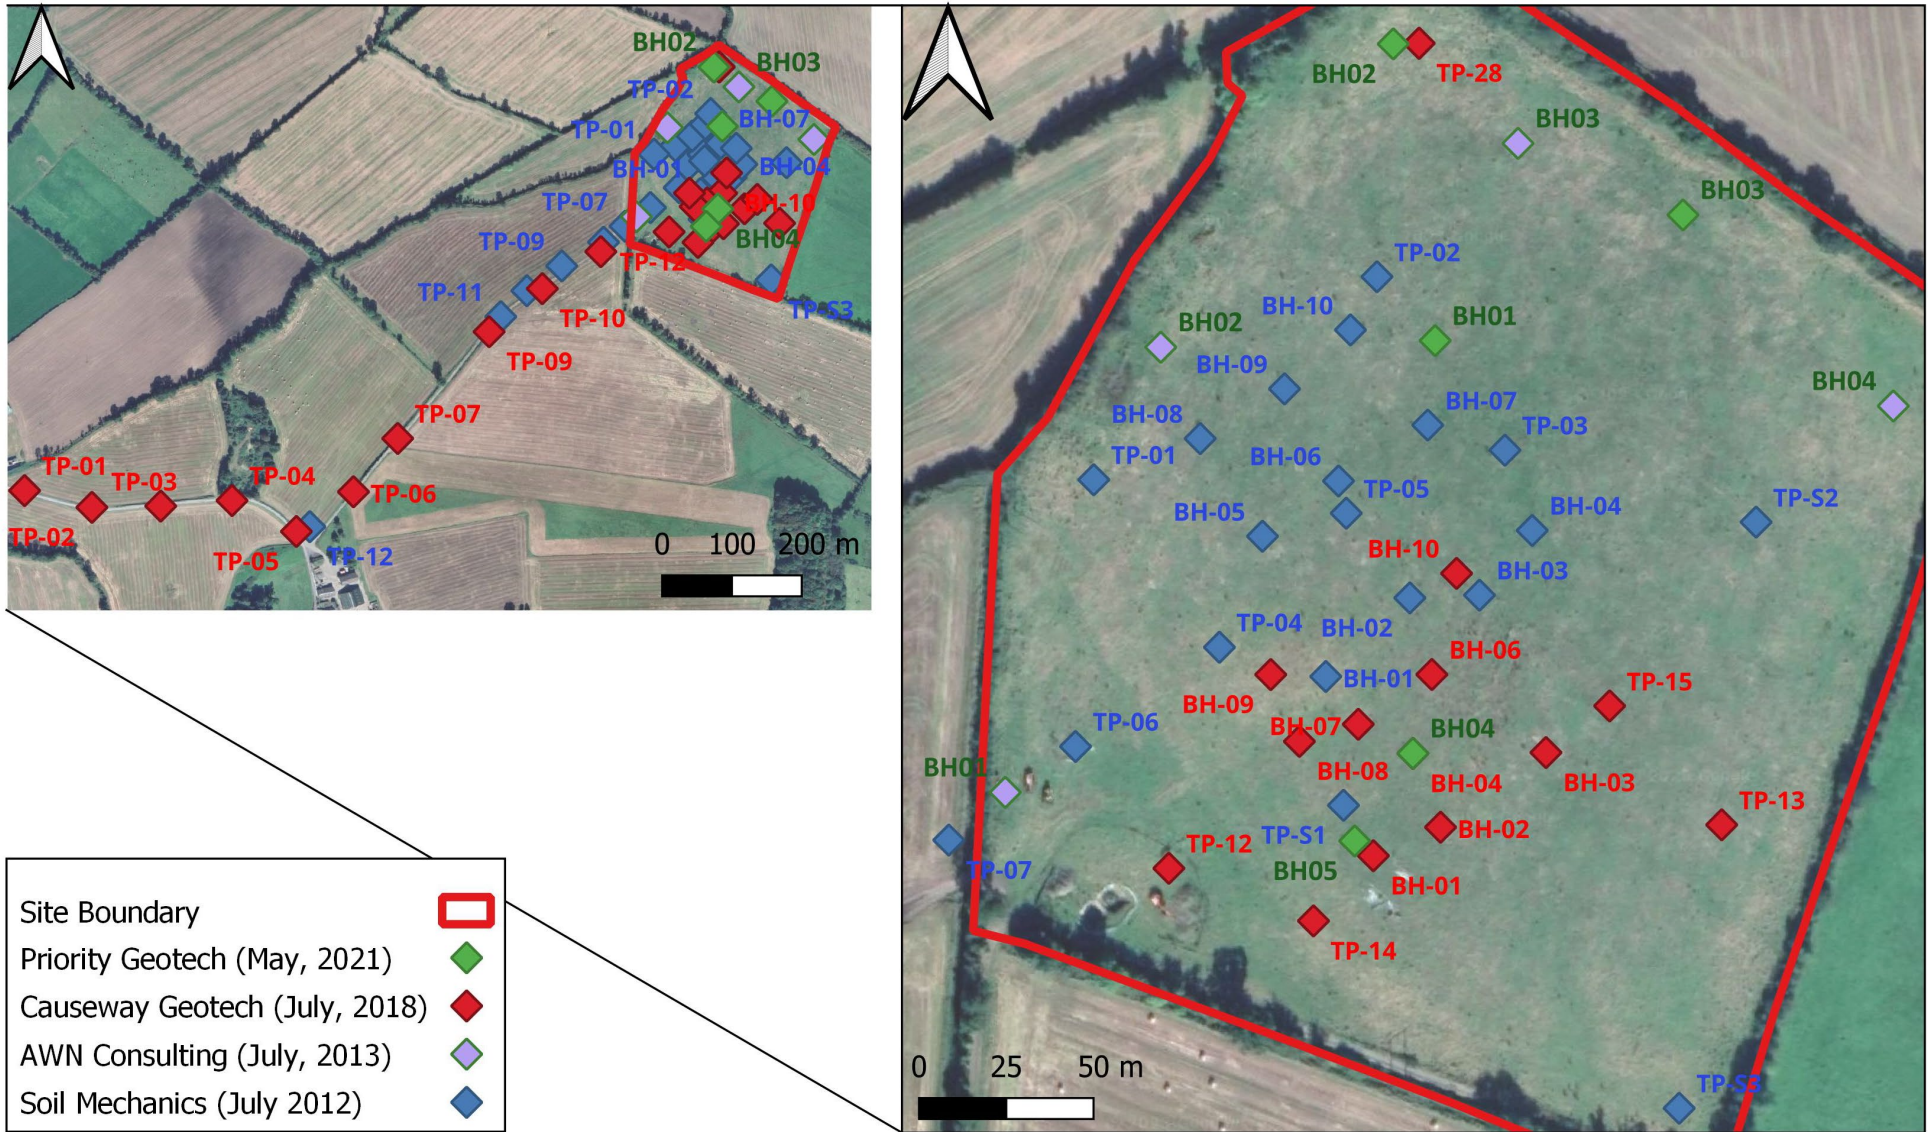
Figure 1 - Locations of historic investigation boreholes and trial pits across the site

The coordinates for BH01 which was installed by Causeway Geotech as per the Borehole Log are 653744.29 E, 692847.44 N. It was noted that when this borehole location, was plotted in plan view as per Figure 1, lies 7 m south-east of the existing borehole demarked as "BH05" on site. The coordinates of BH05 (653738.95 E, 692851.67 N) were verified by an IE Consulting geologist on the 9th May 2023 (see Report IE2219-5866). This was the only observed borehole in the immediate area. It is therefore surmised that BH01 of the Causeway Geotech study was adopted as "BH05" in the quarterly monitoring programme. It is thought that there may have been an error transcribing the GPS coordinates recorded in the Causeway Geotech 2018 Report (No.: 17-0439), as this is the only explanation to derive the existence of BH05. BH05 has since collapsed so will be decommissioned and described in further detail in the subsequent sections.

BH04 from the Causeway 2018 investigation was documented at coordinates 653775.62 E, 692876.75 N. However an IE Consulting site visit on the 9th of May 2023 (see Report IE2219-5866) confirmed the monitoring location of BH04 to be 653755.62 E, 692876.75 N.

Therefore it was confirmed that BH04 was the borehole adopted from the Causeway 2018 investigation into the quarterly monitoring data as an additional data point. However because it was not originally located as a construction monitoring borehole, it will need to be re-located outside of the footprint area.

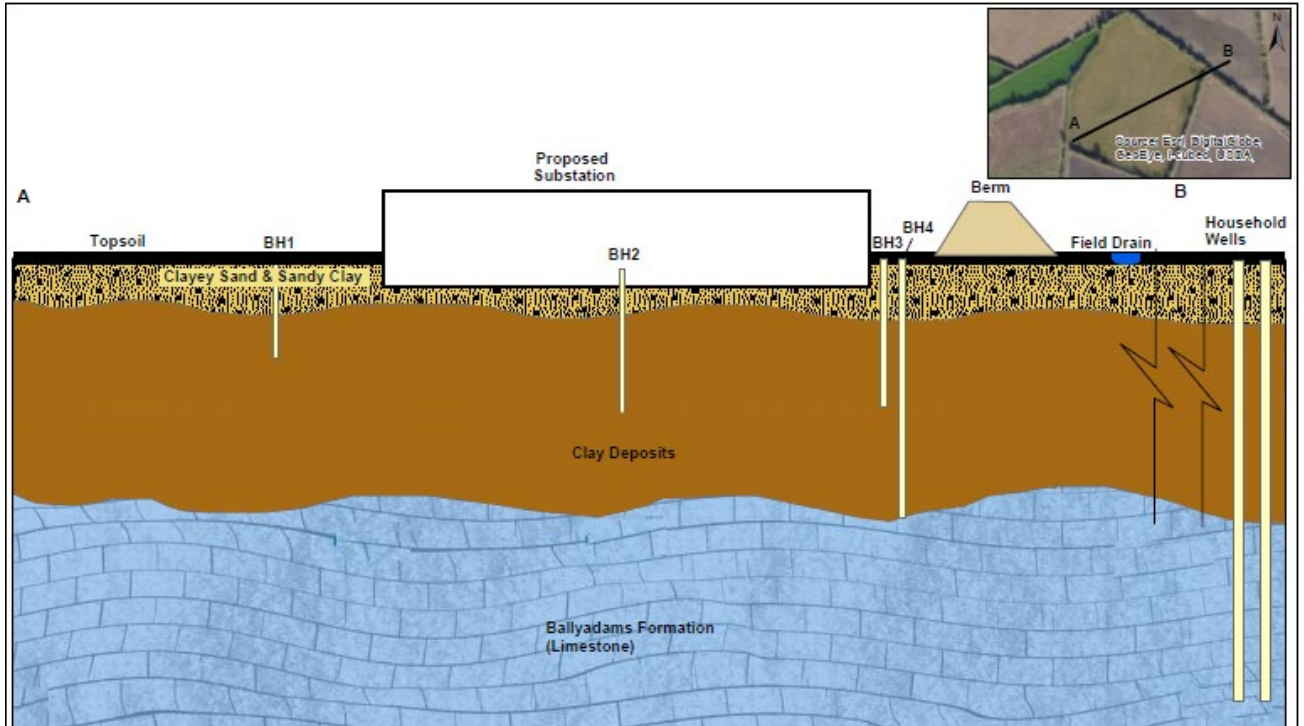
Figure 2 – Conceptual Model Presented in AWN Consulting Ltd. Report (DB/09/4848HR02)

AWN prepared a conceptual model labelled Figure 2 for the site. This cross section was produced based on the Soil Mechanics site investigation in 2012. The following points are notable in relation to this schematic:

- BH02 was the deepest borehole drilled during the 2012 site investigations at 8.50 m depth and did not encounter bedrock. BH04 is depicted as being the deepest borehole; however the log shows that BH04 was only drilled to 6.44 m.
- The Clay encountered during the site investigations is described as stiff to very stiff at depth. The 2012 Ground Investigation report found clay deposits at all locations and did not indicate the possible presence of bedrock. The Clay is described as grey, which is consistent with low oxygen concentrations (indicative of poor percolation rates). Similarly PSD analysis of samples from the boreholes found 30% to 50% fines, which would be consistent with low permeability values.
- The shallow water aquifer or perched water in the clayey sand and sandy clay is not depicted even though groundwater strikes were recorded as shallow as depths of 0.80m in BH03.

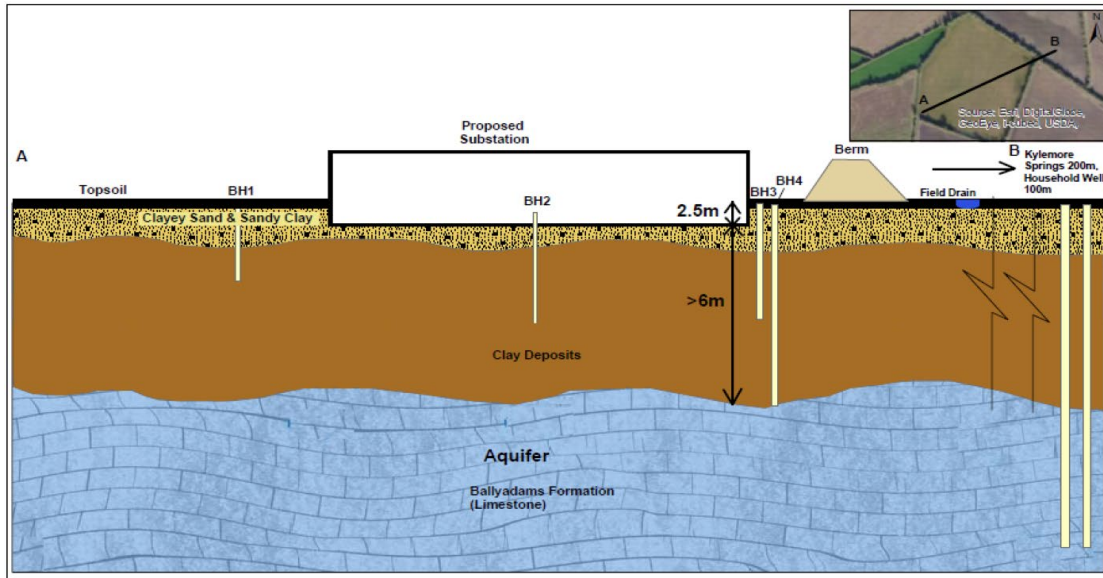
Figure 3- Conceptual Model Presented in Tobin Report (Sep, 2017)

The conceptual model presented in the AWN consulting report was utilised and modified in the Tobin Report to include the following:

- Depth to bedrock was presented as 8.5 m below ground level i.e. 2.5 m foundation depth below ground level plus subsoil of >6 m of subsoil underlying this.

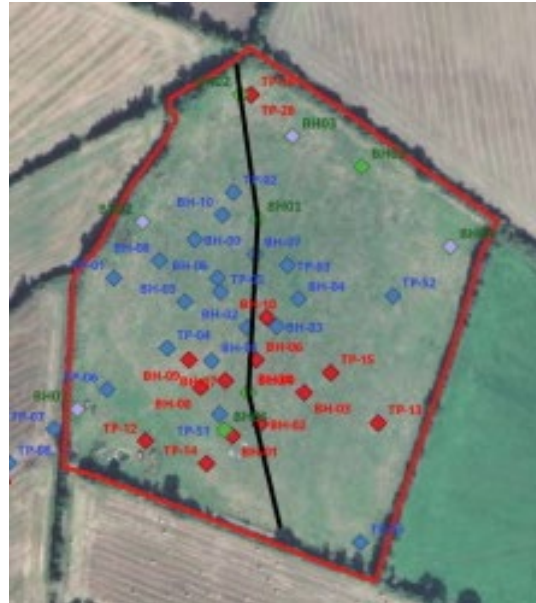
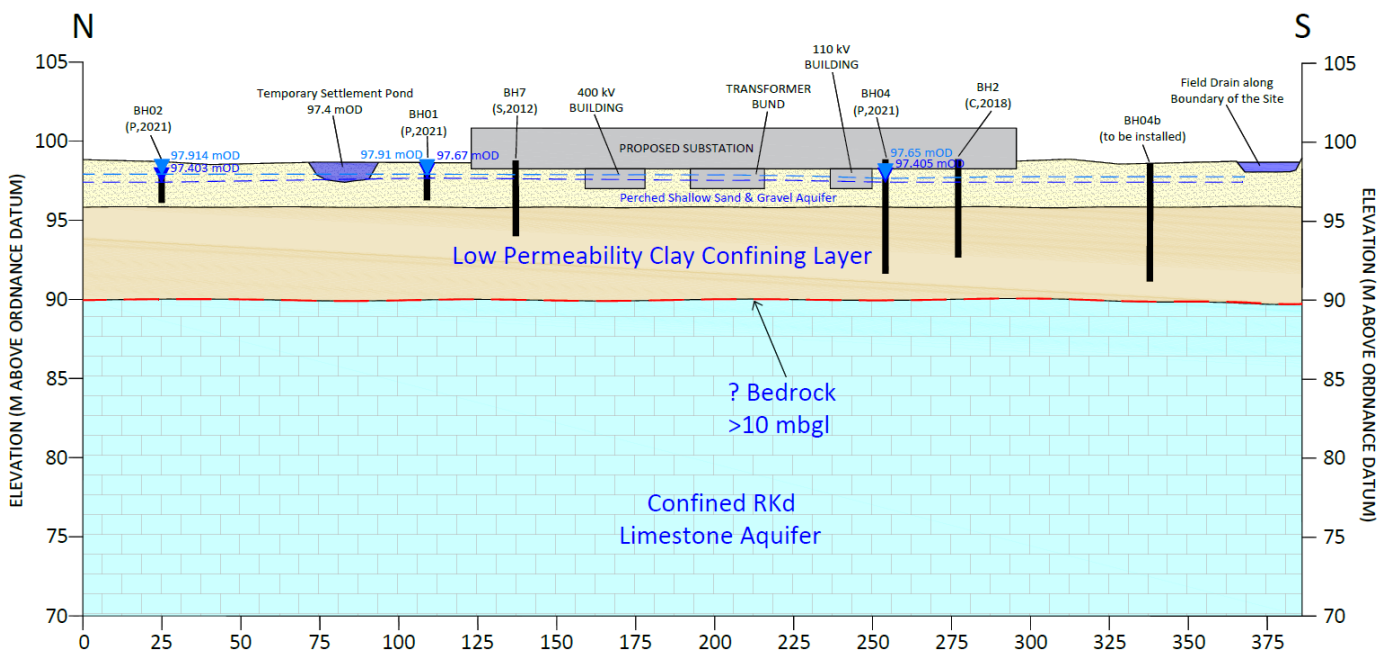
Figure 4 - North-South Cross Section

Figure 4 and Figure 5 show the cross sections illustrating the latest understanding of potential interaction between infrastructure units and the shallow aquifer.

The shallow water aquifer is interpreted based on the highest water level recorded during the quarterly monitoring baseline programme at the applicable monitoring borehole point. This is represented by the upper blue dashed line. The lower line is water levels recorded during the Q2 2023 monitoring on the 24/05/2023.
