**PETRIFYING SPRING SURVEY AND ASSESSMENT
COOLNABACKY, CO. LAOIS**

December 2022

**Report produced by Denyer Ecology for:
ESB**

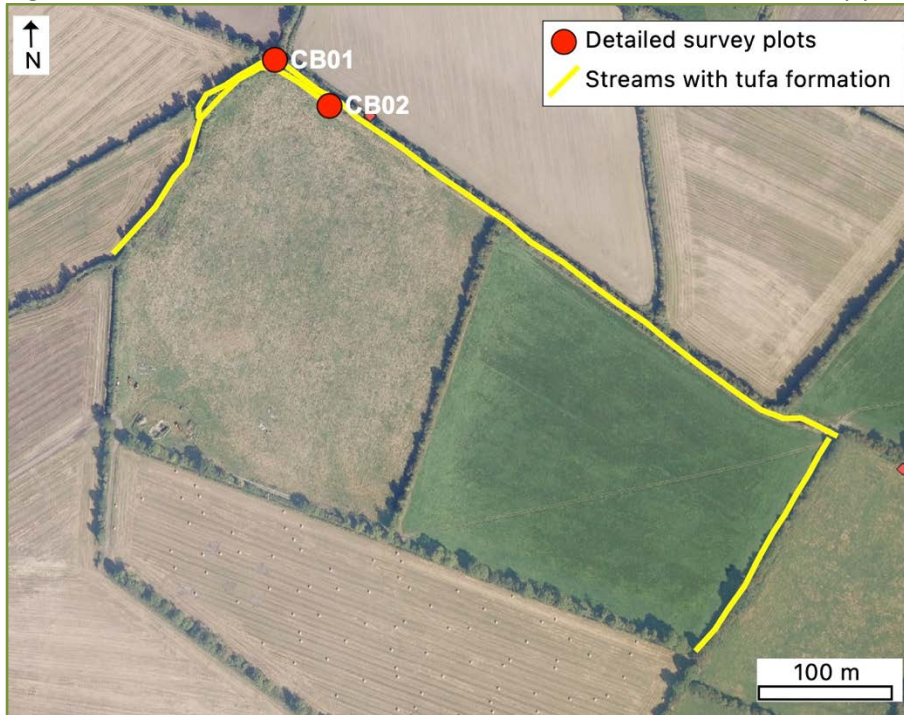
Figure 3.1. Location of streams with tufa formation and detailed survey plots

Several small streams surrounding the site (Figure 3.1) were found to have a high pH and to support tufa formation as stream crust, paludal tufa, oncoids and ooids and cascade tufa. pH values of 8.30, 8.16 and 8.22 were recorded, which is high for lowland streams and typical of petrifying springs. Cover of tufa within the streams ranged from absent to 90% of the stream bed (e.g. Photograph 3.1). The streams had a good flow, despite the season and are highly likely to be largely groundwater fed. Positive indicator species (e.g. Photograph 3.2) for the Annex I priority habitat were rare. This is likely

to be because the streams also act as drainage ditches and receive some surface water (and nutrients) from adjacent lands, increasing water depth at certain times of the year. The surveyed streams with tufa deposition along some or all of their length are shown in Figure 3.1.

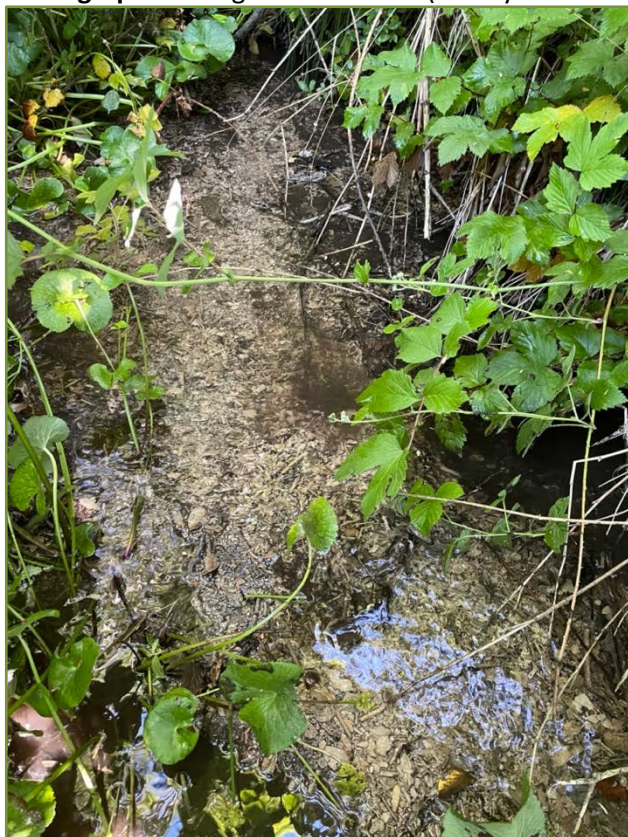
Photograph 3.1. High cover of tufa (mainly oncoids and ooids) in section of stream

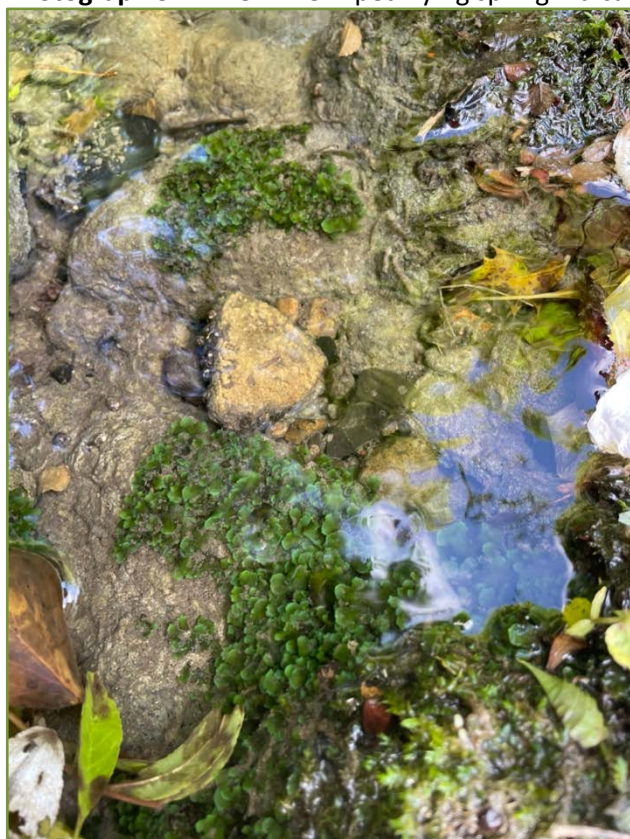
Photograph 3.2. The Annex I petrifying spring indicator species *Pellia endiviifolia* in a stream section

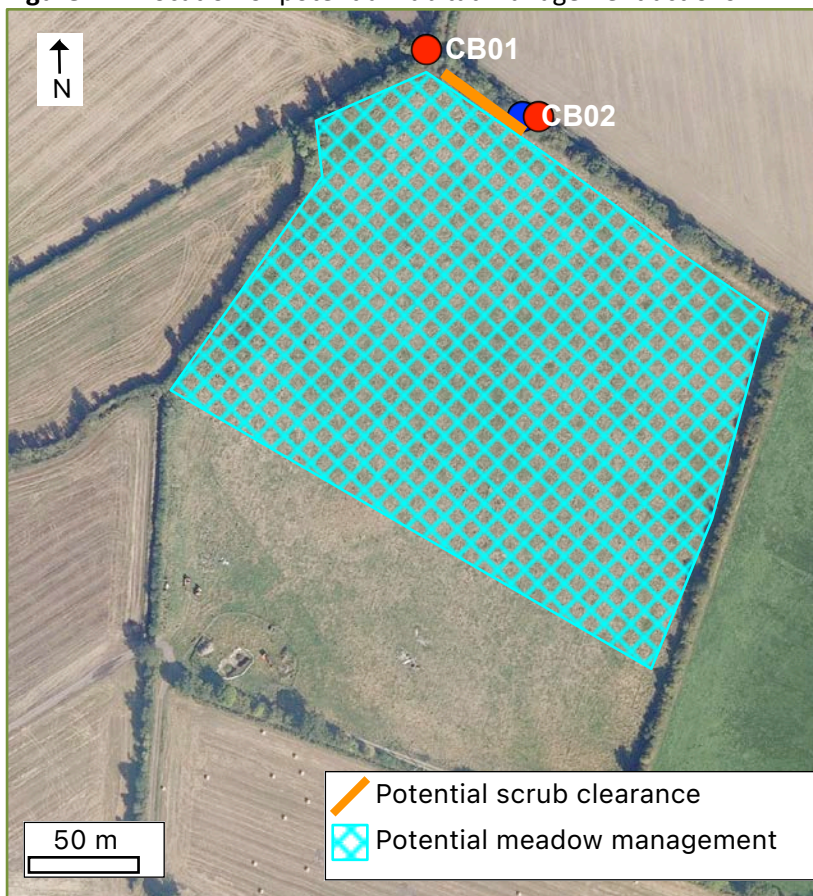
Figure 4.1. Location of potential habitat management actions

- Stream 2, which runs along the inside of the northern boundary of the site, is becoming overgrown with tall vegetation. This is shading the stream and reducing species richness in the tufa forming sections. Clearance of scrub from the ditch edge on the south-west side (Figure 4.1) would reduce the shading. This should only be undertaken with input and supervision from the project ecologist, to ensure that there are no negative impacts on fauna using this area of the site. Once agreed, an ongoing maintenance plan can be created.

- In addition to localised scrub clearance, annual mowing of the grassland in this area (Figure 4.1) would prevent the re-development of long vegetation and scrub. This could be an annual cut of the grassland around mid-August, with the cuttings removed. This would also enhance species diversity in the grassland. Not all of the grassland needs to be cut each year and retaining some areas of long grass would provide refuge for overwintering insects and other fauna. Again, this should only be undertaken with input and supervision from the project ecologist. Once agreed, an ongoing maintenance plan can be created.

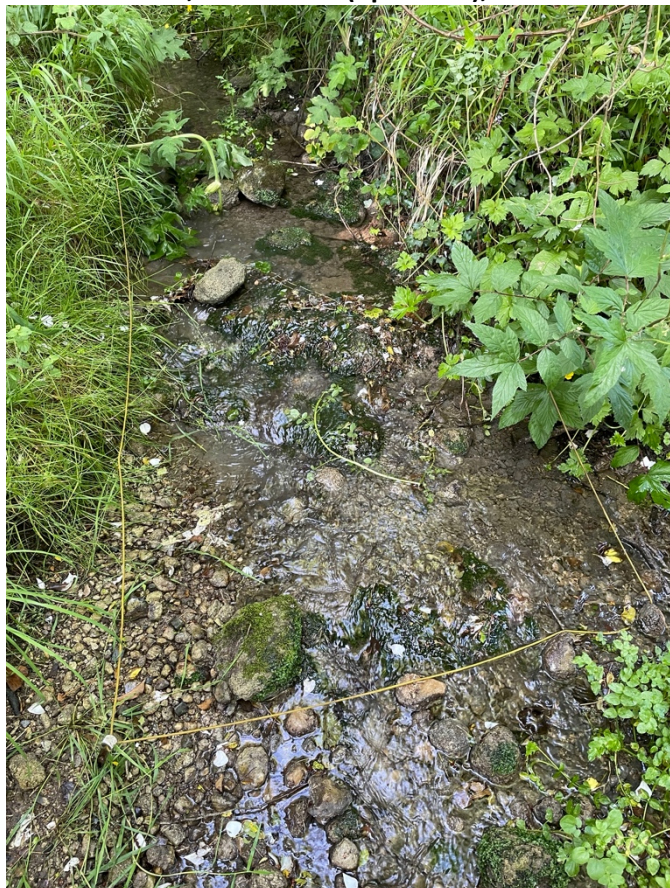
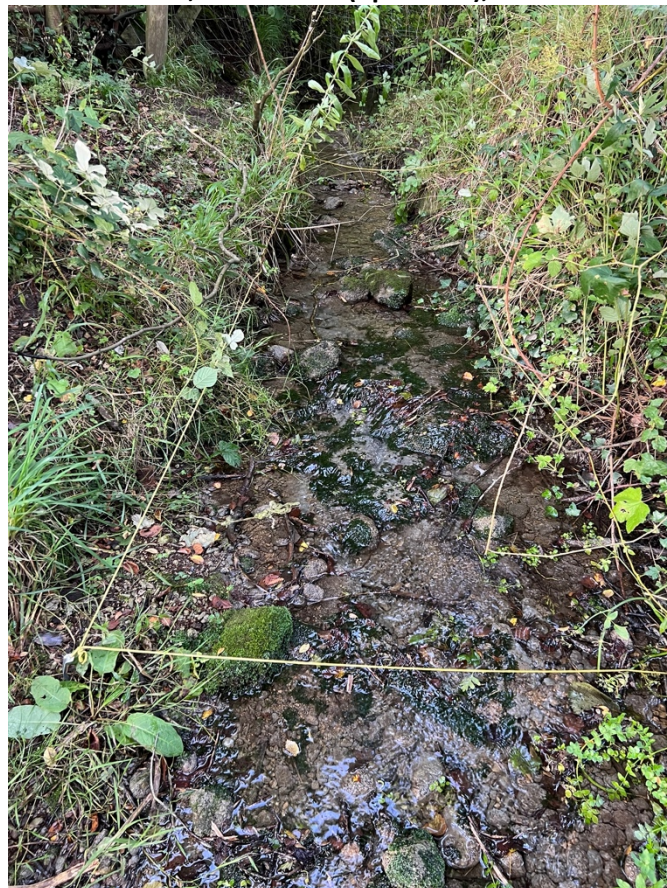
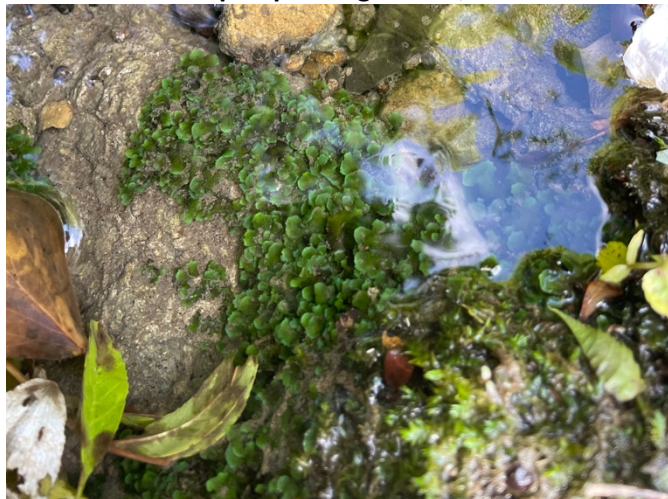
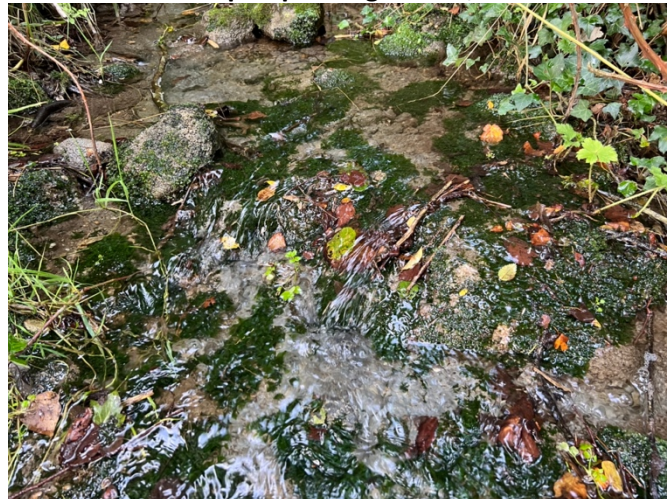
Photo 1.3. Plot, view to SW (upstream), 2021

Photo 1.4. Plot, view to SW (upstream), 2022

Photo 1.5. Close up of plot vegetation, 2021

Photo 1.6. Close up of plot vegetation, 2022

Impacts of grazing			
Field layer height	<2cm	Height between 10 and 50cm	PASS*
Trampling/dung	None recorded	Impact should not be abundant/dominant	Result = none recorded PASS
Overall Structure & Functions Assessment			
All pass or one minor/borderline fail AND, if some indicators are Not Determined, the number of passes is at least five AND there is a pass for Positive Indicator Species		Green - Favourable	
1 - 2 Fail		Amber - Unfavourable Inadequate	UNFAVOURABLE
>2 Fail		Red – Unfavourable Bad	
Future prospects: Negative activities			
None recorded			UNFAVOURABLE

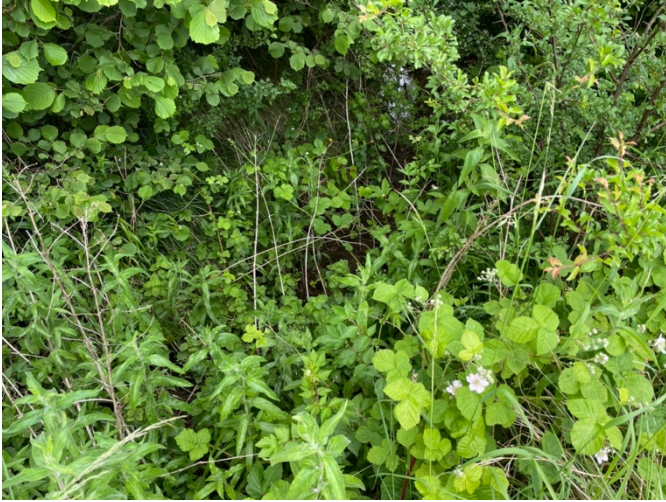
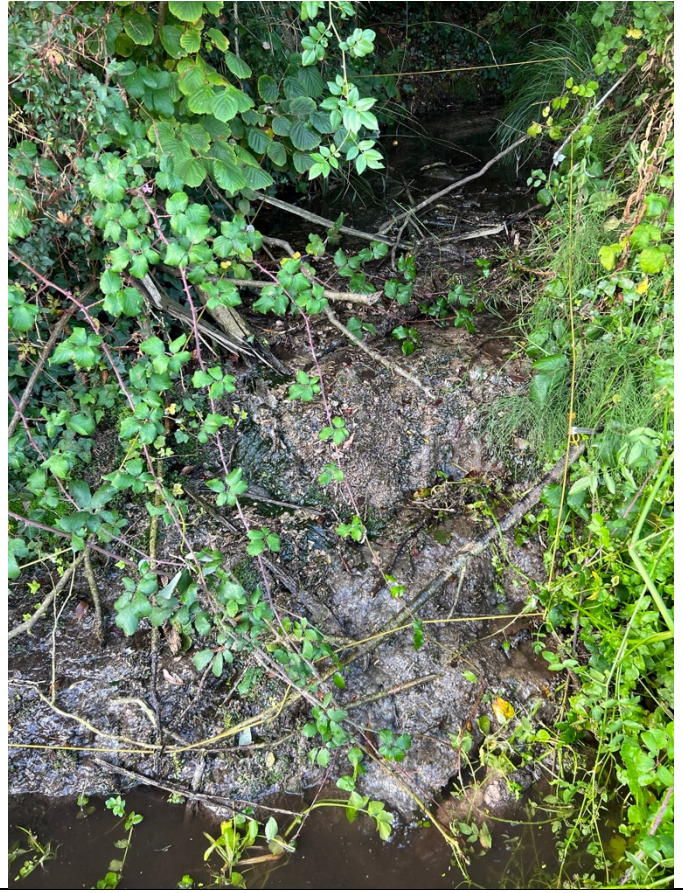
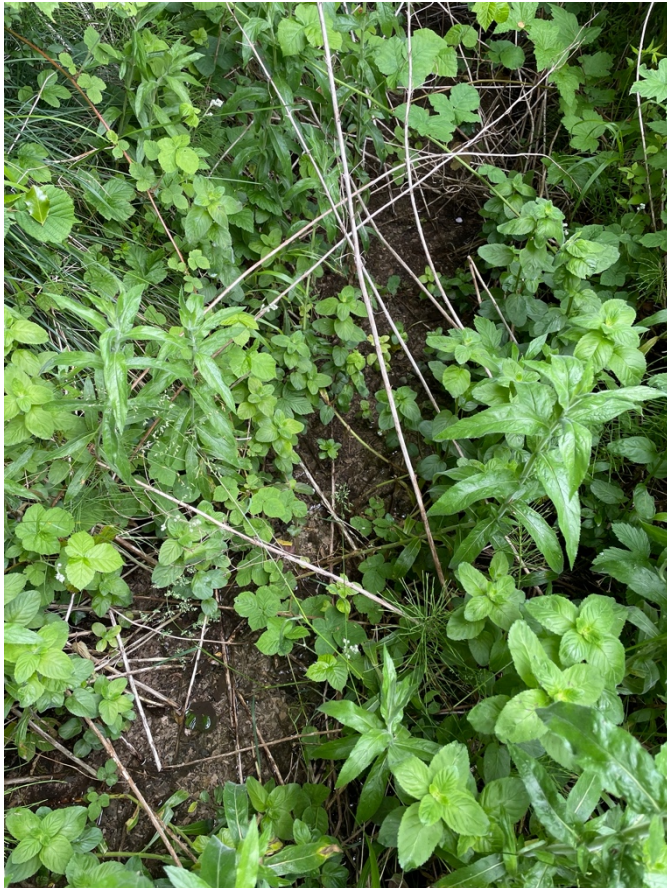
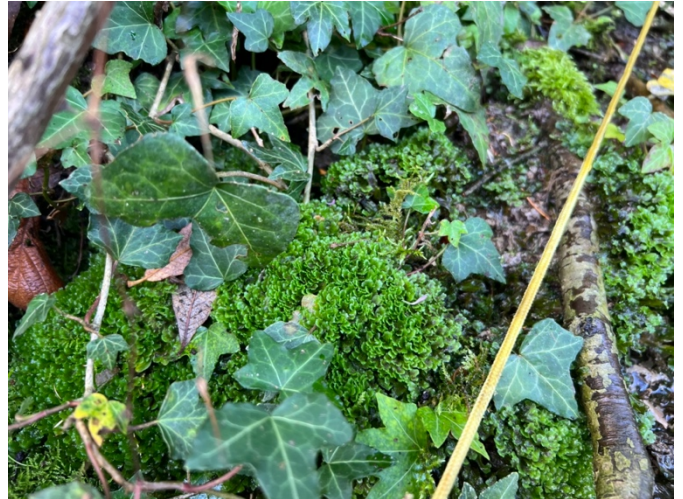
Both plots fail the condition assessment (Table 3.3). This is because of the low number of positive indicator species, high nitrate levels and shading in plot CB02 (Stream 2).

Photo 2.3. Plot, view to NE (across stream), 2021

Photo 2.4. Plot, view to SW (upstream), 2022

Photo 2.5. Close up of plot vegetation, 2021

Photo 2.6. Close up of plot vegetation, 2022

Spring water composition and flow			
Nitrate level	Upstream value of 39.4 mg/l and downstream of 37.7 mg/l	No increase from baseline and not above 10 mg/l	PASS
Phosphate level	Upstream value 2021 of <15 mg/l and downstream of <15 mg/l	No increase from baseline and not above 15 µg/l	PASS
Water flow	No obvious alteration	No alteration of natural flow	PASS
Impacts of grazing			
Field layer height	>1m (2021); 5-20 (2022)	Height between 10 and 50cm	FAIL*
Trampling/dung	None recorded	Impact should not be abundant/dominant	Result = none recorded PASS
Overall Structure & Functions Assessment			
All pass or one minor/borderline fail AND, if some indicators are Not Determined, the number of passes is at least five AND there is a pass for Positive Indicator Species		Green - Favourable	
1 - 2 Fail		Amber - Unfavourable Inadequate	UNFAVOURABLE
>2 Fail		Red – Unfavourable Bad	
Future prospects: Negative activities

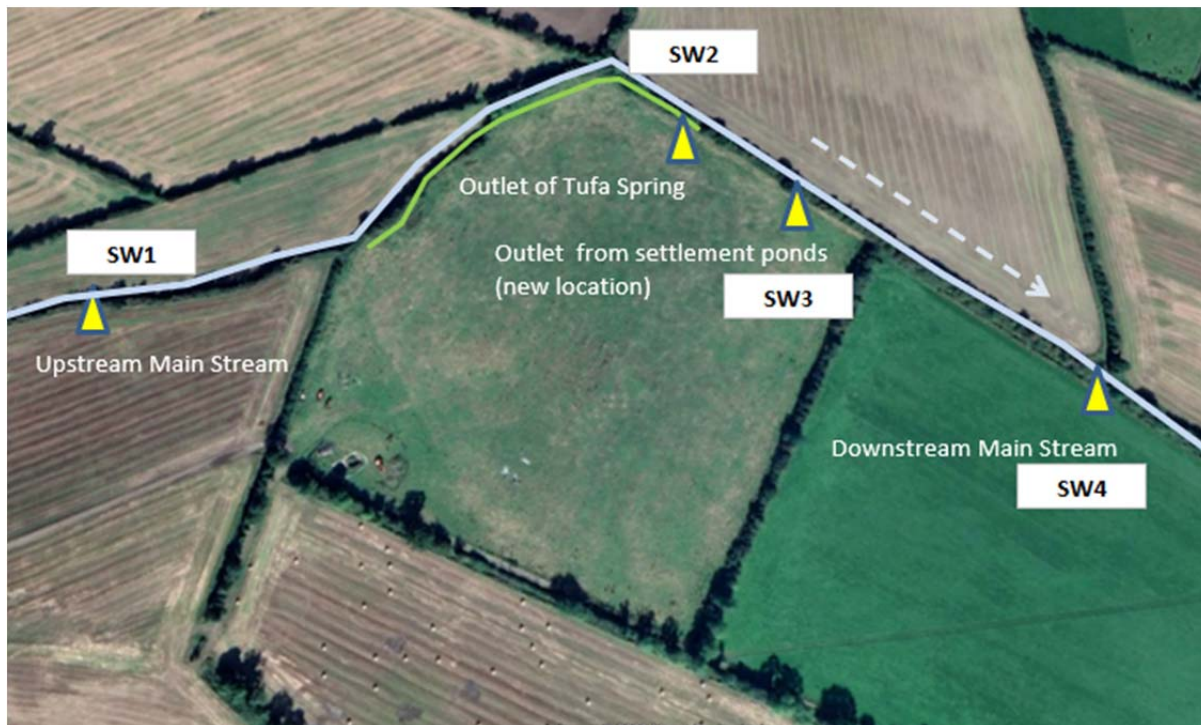
The results are all very similar suggesting, that all streams are calcium rich groundwater fed in the area.

There is no evidence of any deterioration in water quality as the stream passes the site.

The only negative is the elevated Nitrate concentrations since nutrient enrichment can cause damage to Tufa spring habitats. The results suggest some nutrient loss to groundwater from the agricultural activity in the vicinity of the site.
