# BATS AND BRIDGES

## AN EVALUATION OF SELECTED BRIDGES

### IN LAOIS AND OFFALY

October 2007

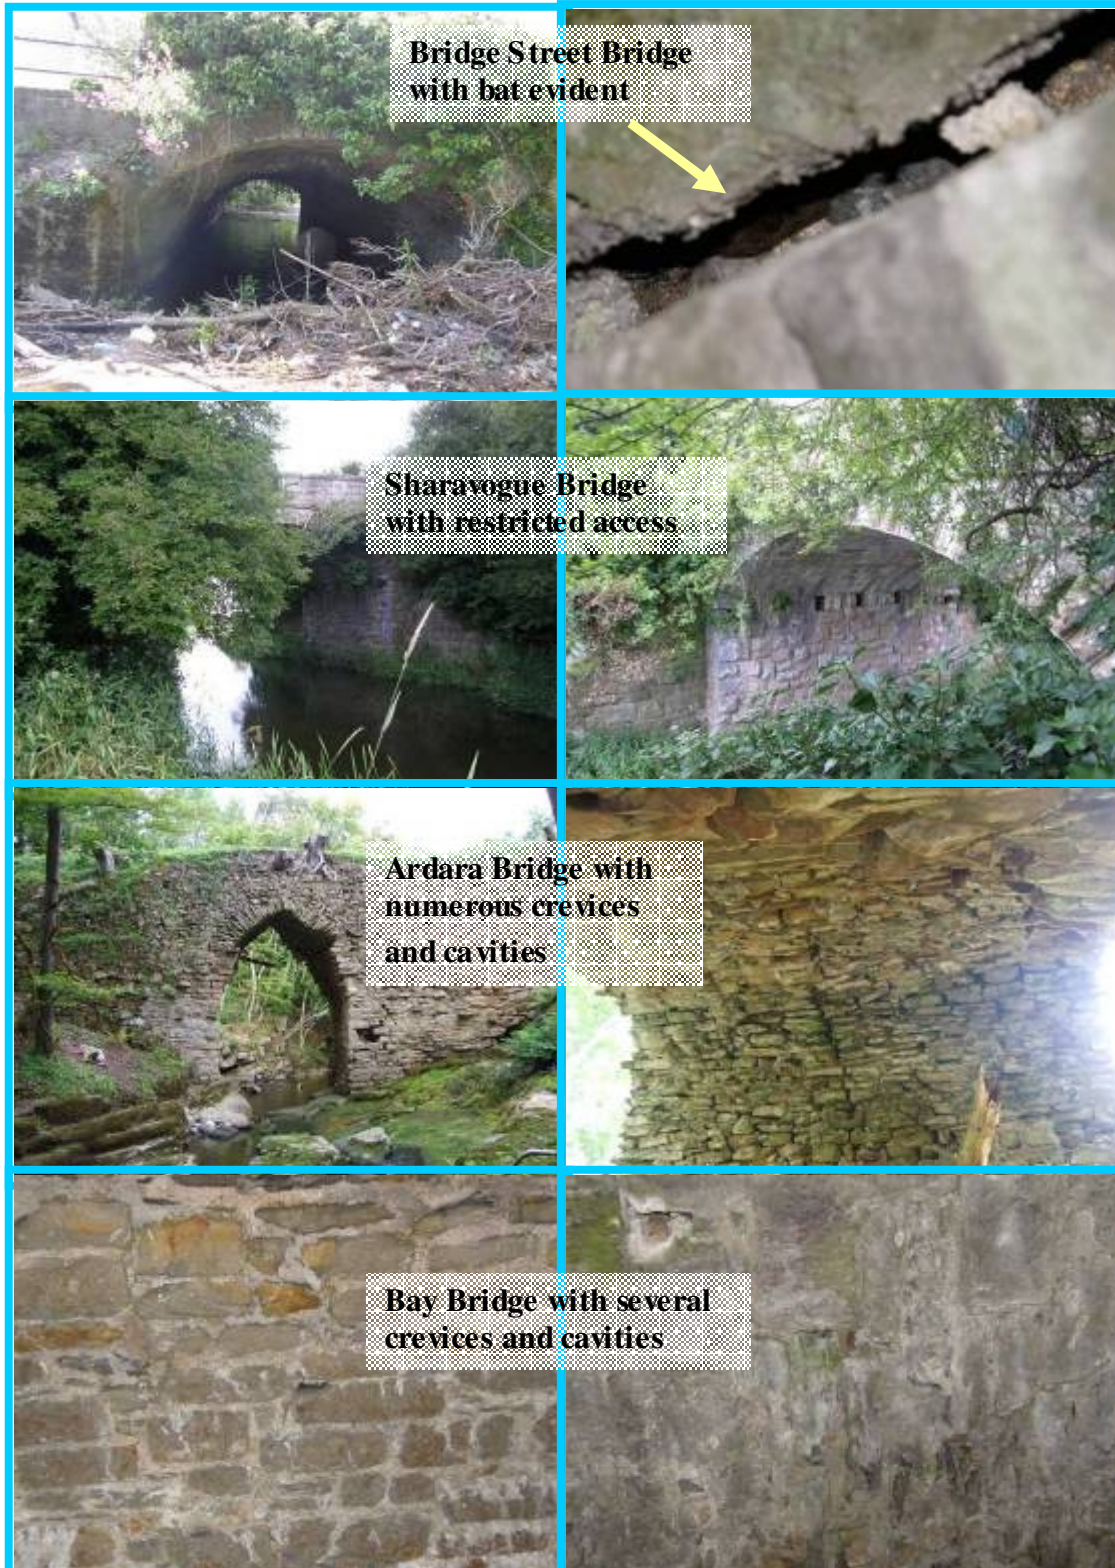
**Plate 1: Bat detector surveys of bridges**

The above bridges were examined using bat detectors (Pettersson D240x and QMC Mini 3 heterodyne bat detector) at dusk to determine if bats were present deep within the stonework. Two of the bridges were bat roosts at the time of examination. A bat can be seen in the crevice of the second photograph

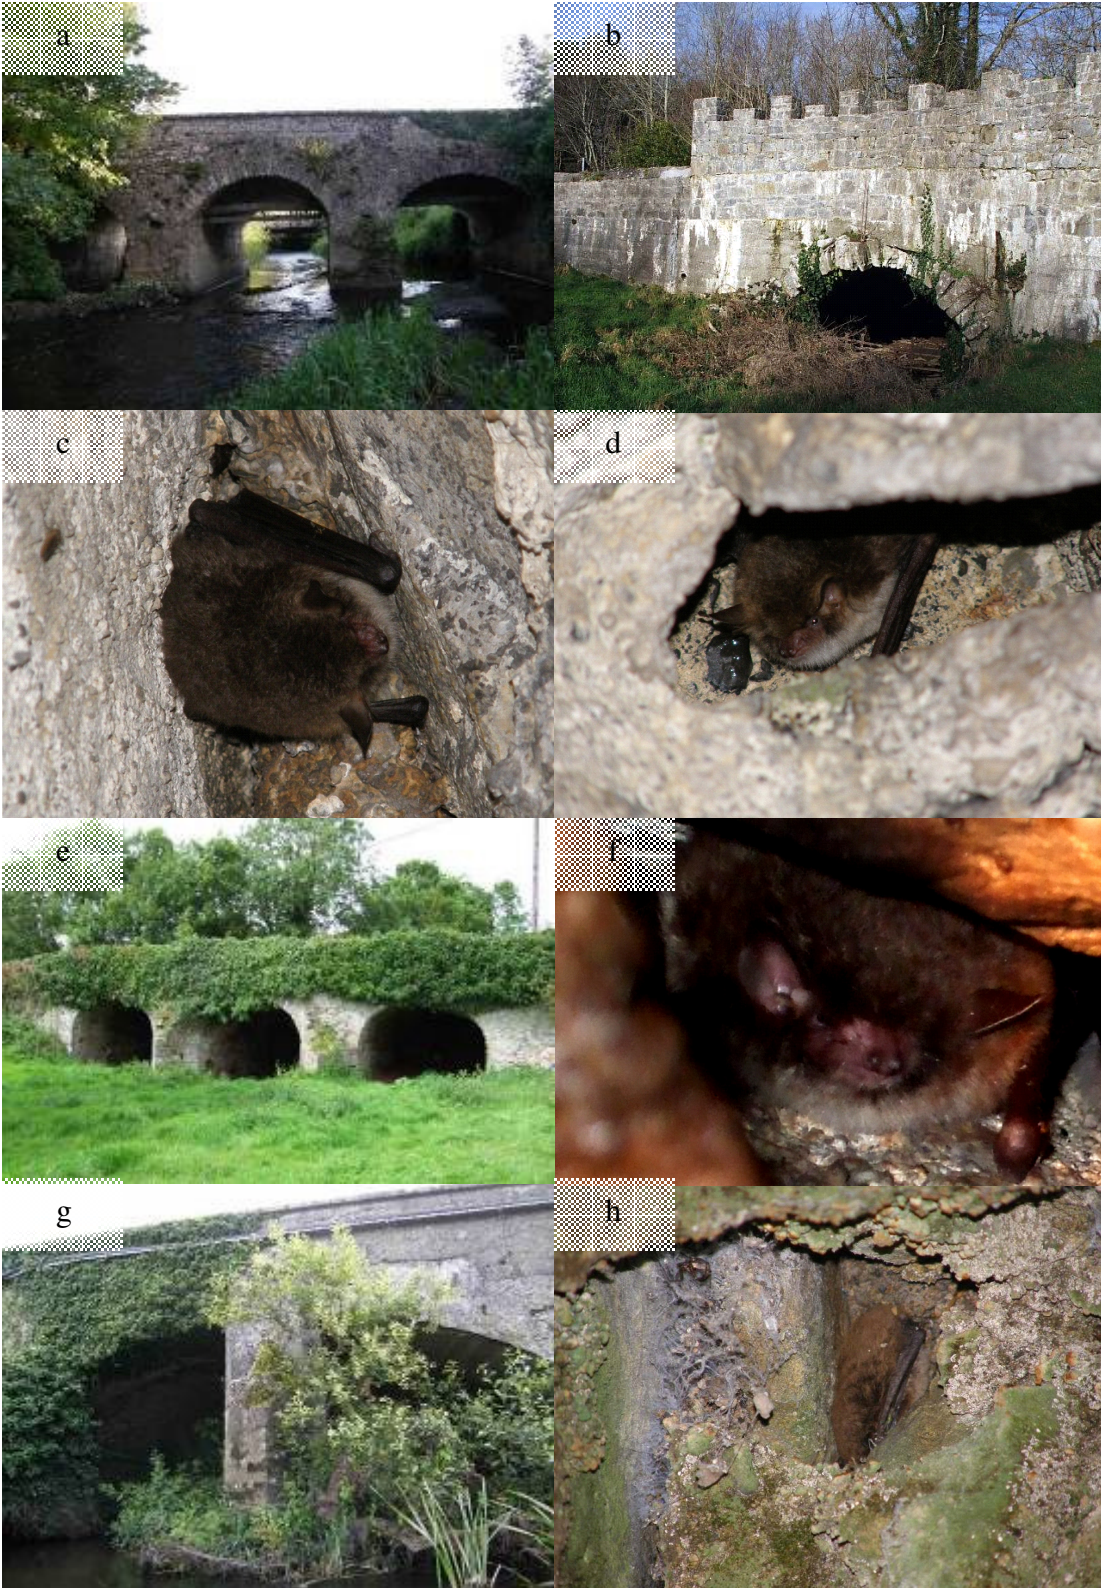
**Plate 2: Bat**

- a) Mucklagh Old Bridge and underpass with b) and c) roosting Natterer's bats
- d) Rahan dry arches with e) Daubenton's bat close-up
- f) Bridge at Lisnageeragh with g) Daubenton's bat

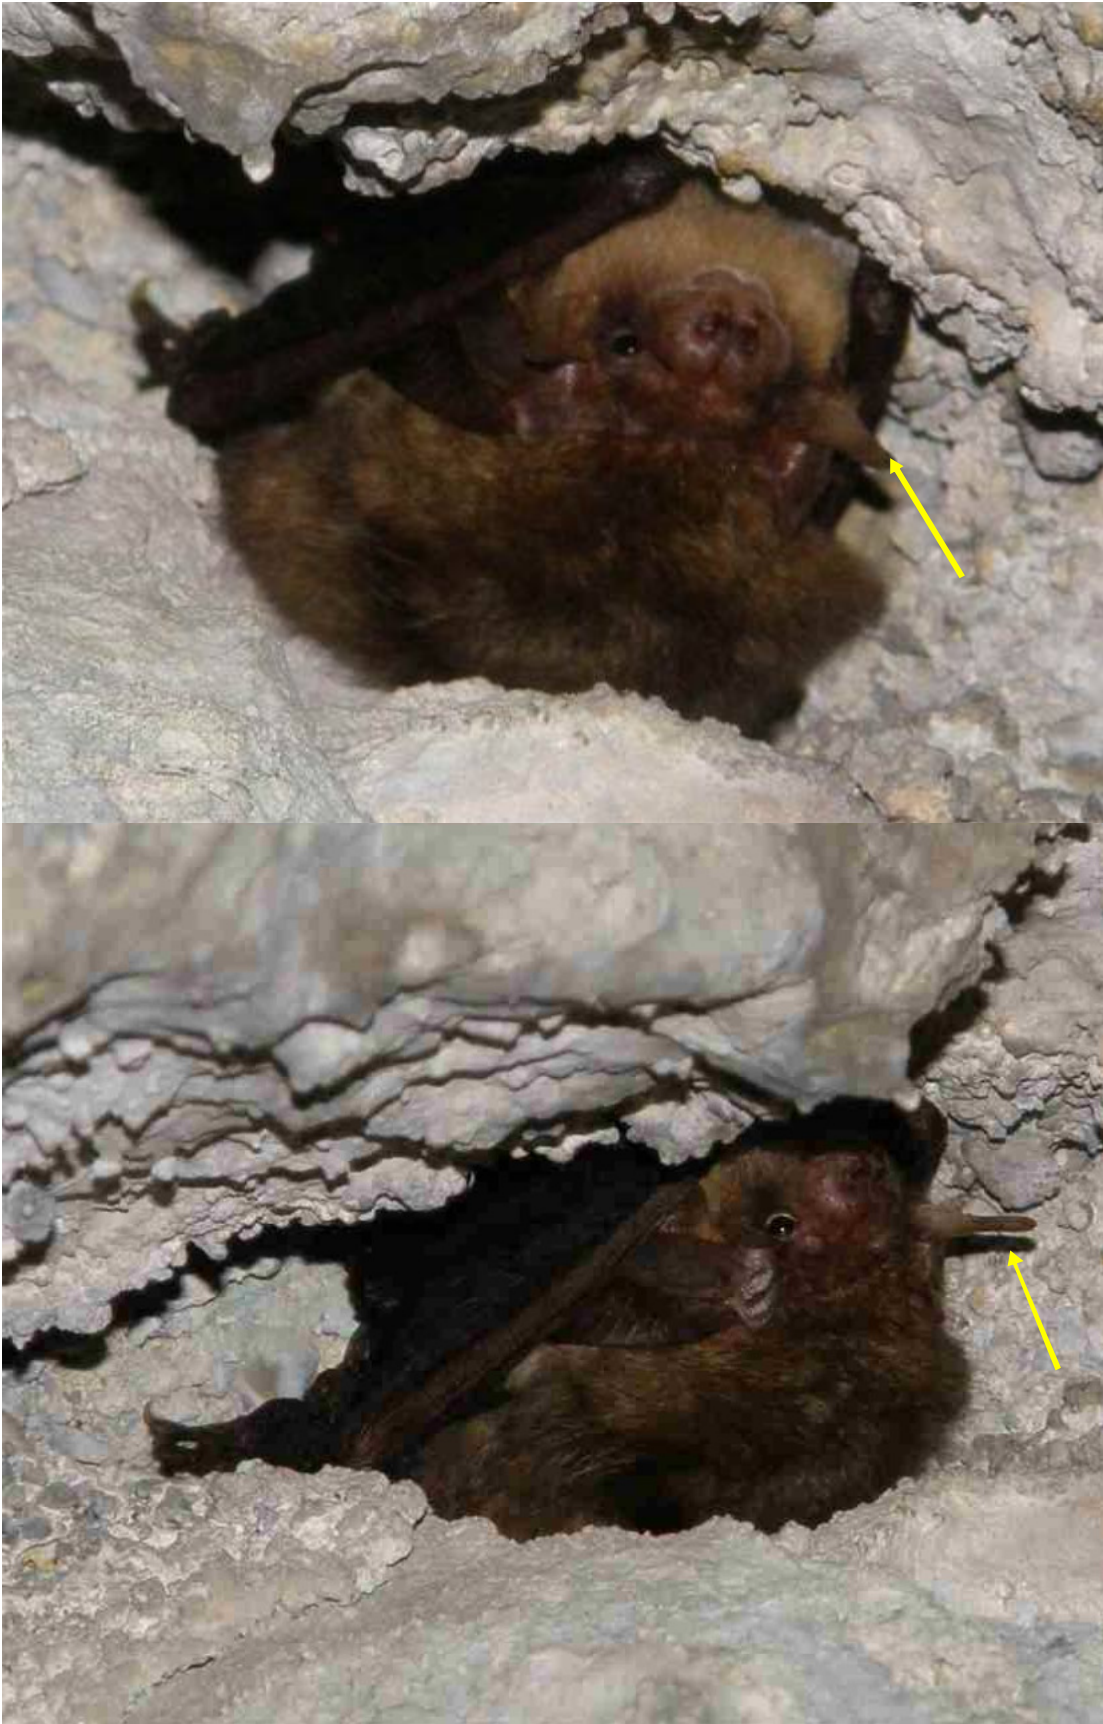
**Plate 3: Brown long-eared bat in bridge.**

Once the ear is folded, the tragus (see arrow) may look deceptively like an ear and lead to misidentification. Natterer's bat is the species with which it is most commonly confused

Brown long-eared bats were thus found both in a dry arch and in a wet arch over a river in this assessment (see Plate 3).

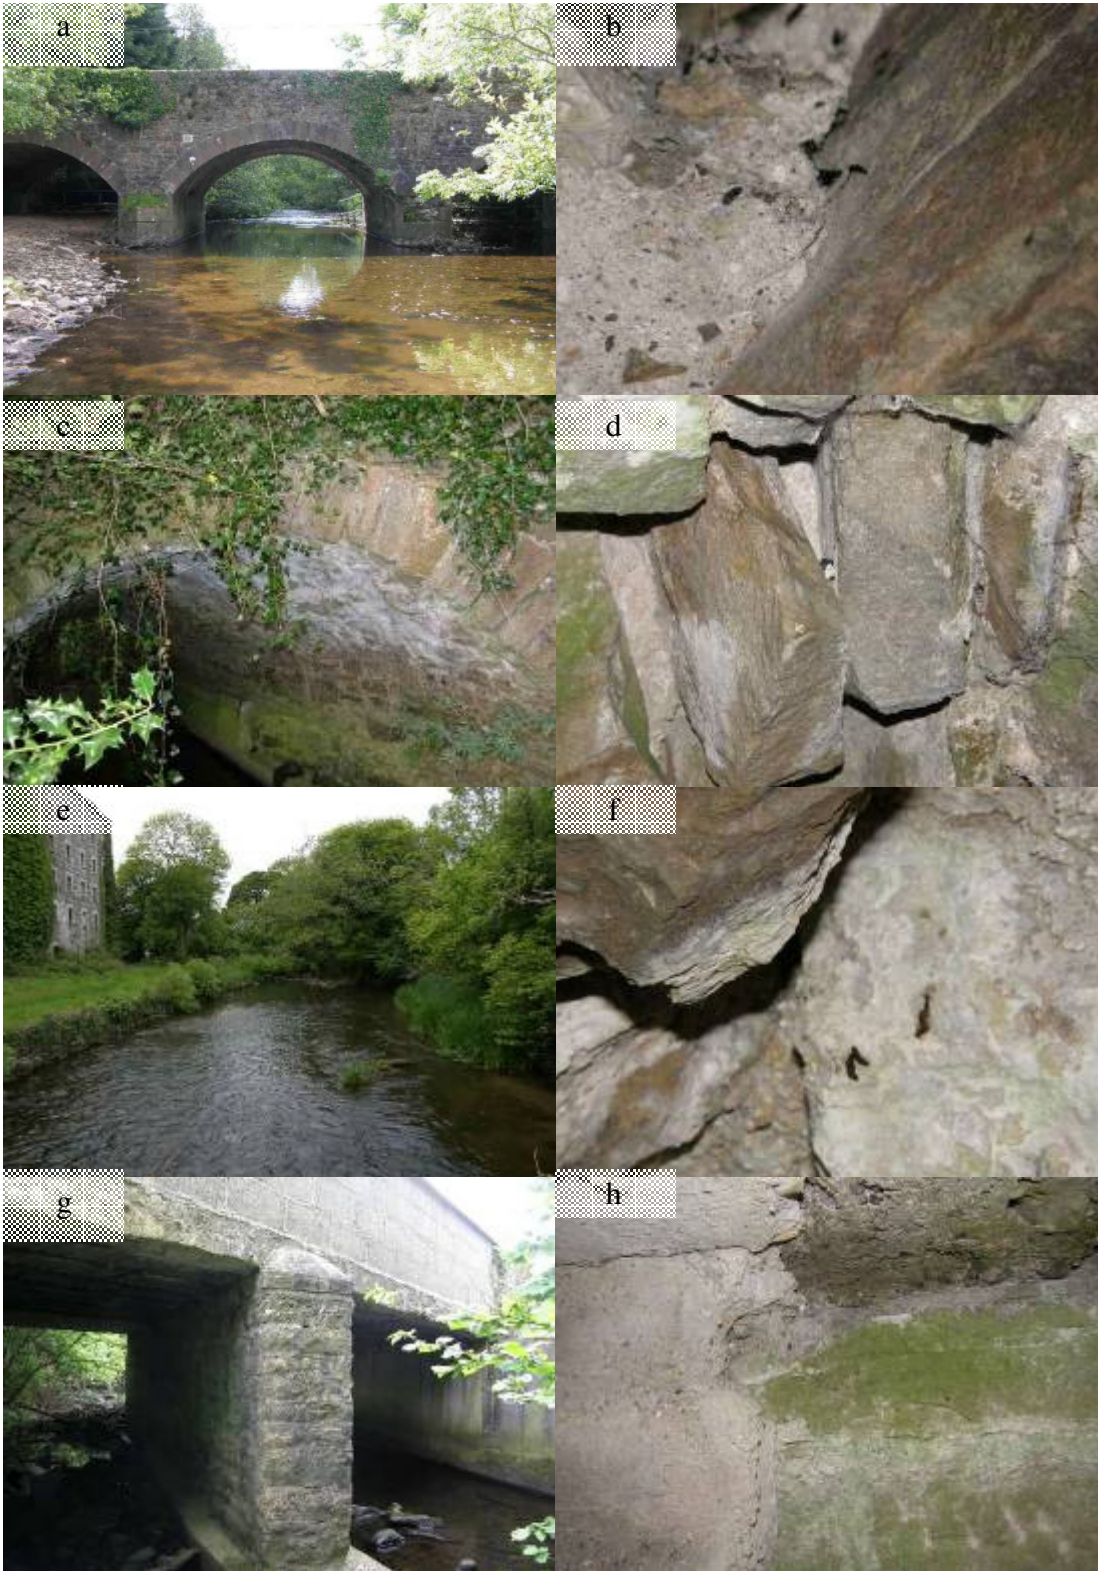
**Plate 5: Bridges with bat droppings but with no bats present**

a) and b) Derrynaseera, c) and d) Esker II, e) and f) Derrinasallow, g) and h) Ballymacrory Bridge had bat droppings on the bridge but this is clearly due to perching on, rather than roosting within the bridge

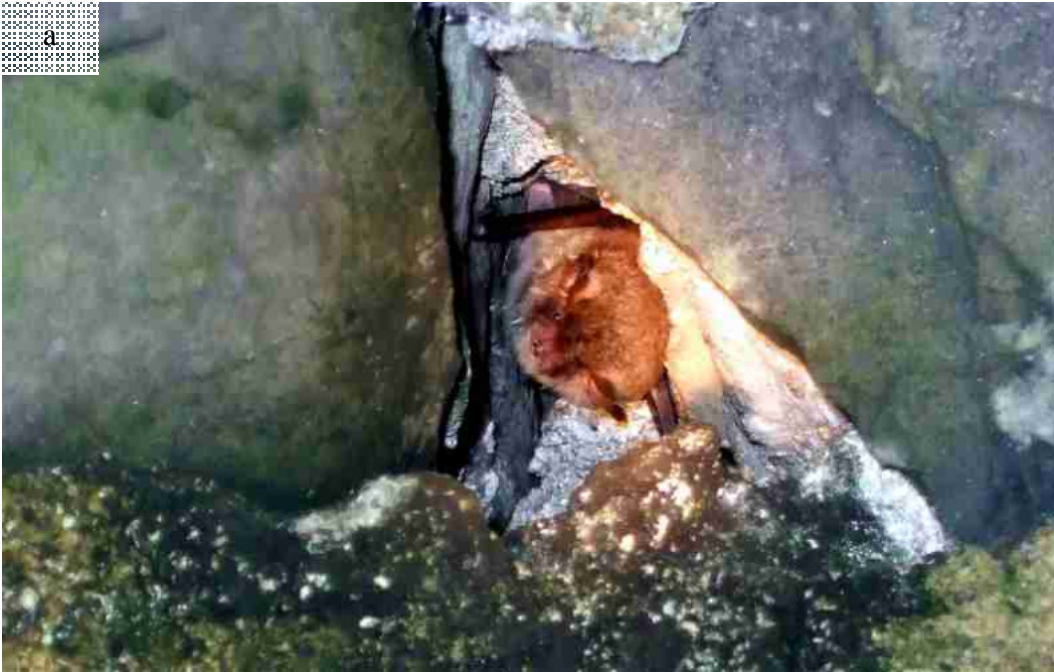
**Plate 6: Roosting Daubenton's bats at different levels of visibility**

Daubenton's bats are most often tucked out of view in a cavity (a) but may on rare occasions be visible externally (b) as in this modern culvert on the Meath / Dublin border.

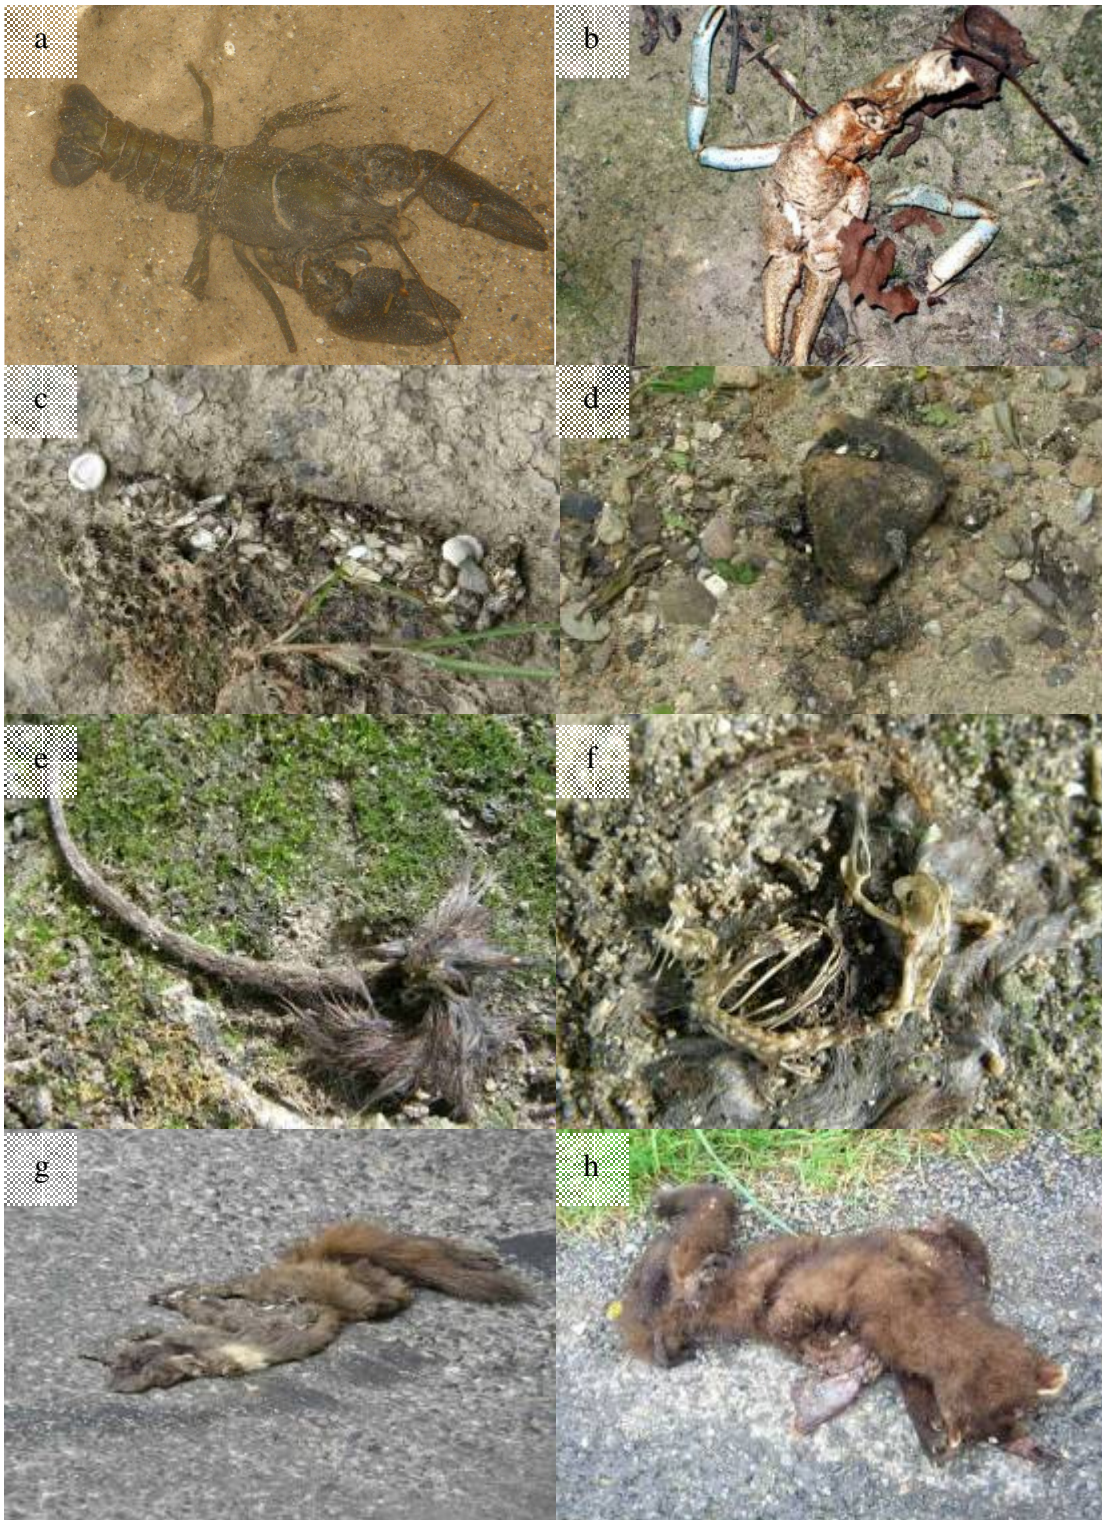
**Plate 7: Mustelids: Otter and mink signs and pine martens**

- a) Freshwater crayfish are a prey item of otter and remains were found in and with several otter spraints, b).  
 c) Otter spraints were widespread in the two counties  
 d) Mink spraints were noted at 15 of the 102 bridges and were present in both counties  
 e) The rat tail and f) nestling deposited under a bridge and are most probably otter discards  
 g) and h) Pine marten on New Bridge and northwest of Kilcormac respectively

One of the food items noted in both counties was the freshwater crayfish (*Austropotamobius pallipes*). One live crayfish was noted at Longford Bridge in Laois (see Plate 7).
