AN ECOLOGICAL AND INDUSTRIAL HERITAGE SURVEY OF THE MOUNTMELICK CANAL

John Feehan and Fred Hamond

An action of the Laois Heritage Plan 2002-2006

for
Laois County Council
October 2006

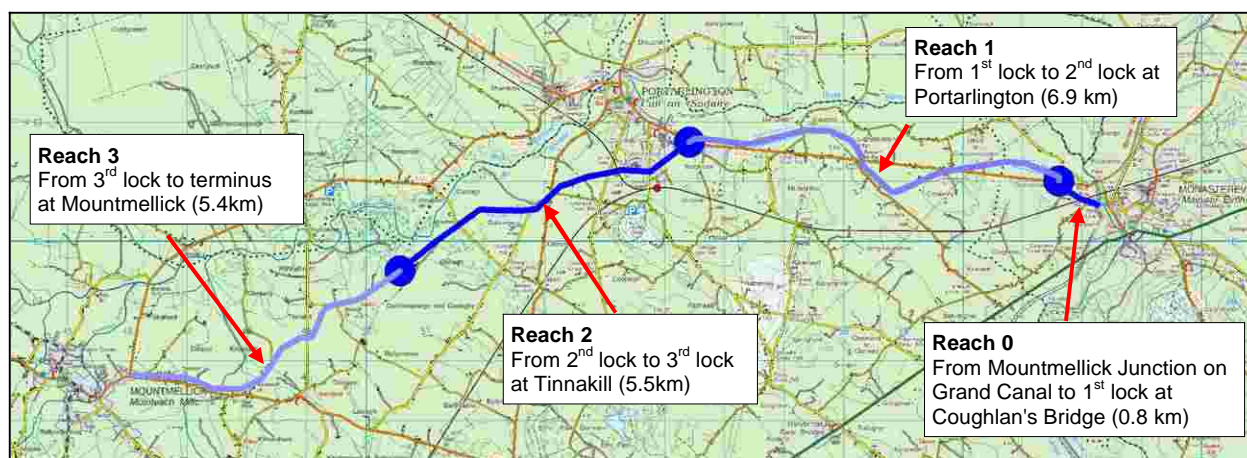
Fig 3.1 Course of Mountmellick Canal and numbering of reaches.

For the purposes of description, the canal has been divided into four reaches, each demarcated by a lock at one or both ends and numbered from east to west in the same direction as the canal was constructed (fig 3.1).

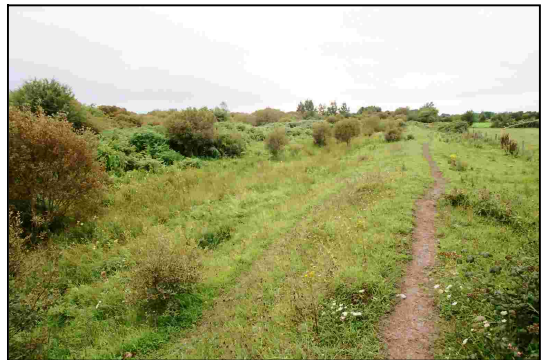
Fig 4.1 Looking north-west along dewatered canal (S102) from just north of 1st lock.

Horses have access to the canal all along this stretch. This has caused poaching and severe erosion to the banks so that it has almost lost its profile in places, but on the other hand it has kept it open and made it possible to walk the entire length of this stretch (fig 4.1). For much of it, the banks are covered with dense bracken, but in places (especially towards the east) it has the character of limestone grassland, with many species of interest (it would be much clearer in winter). These include lady's bedstraw, marjoram, red bartsia, wild carrot, eyebright, fairy flax, black knapweed, yellow centaury, quaking grass, self-heal, red clover, ribwort plantain, bird's-foot trefoil, greater hawkbit, cat's-ear, common agrimony, cinquefoil. A striking feature is the great profusion of yellow rattle in places, a plant of less intensively managed grassland which has declined greatly over the last 50 years or so.

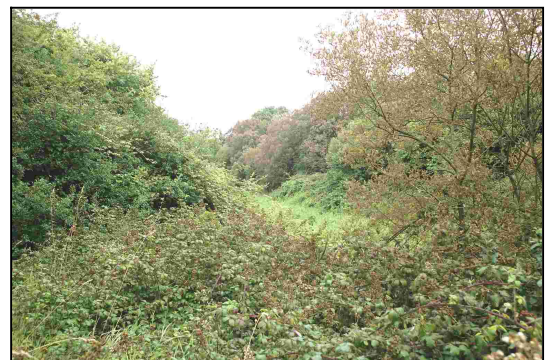
Fig 4.3 Looking north-east from south-west end of dewatered section 106.

East of Wheelahan's Bridge tarred roads have been laid down on both sides of the channel; the road on the south side is overarched with tall hazel hedges. The canal here contains open water: but it is stagnant, completely overgrown with woody vegetation (principally grey willow and ash), inaccessible and of little ecological interest. Away from the canal, hedge banks contain much false brome, and tutsan was noted. Further on in this direction the canal has been entirely fenced in at first, then levelled, only a hedged bank plus ditch (with a step drop down to the ditch on the south side, but the hedge, as usual, much overgrown and unmanaged.

Opposite the new house at the end of the new road on the north side there has been so much dumping in the channel that it is completely blocked; crack willow, tall white willow and black poplar occur at this point. South-west of this point the channel is completely filled with aquatic vegetation, reed sweet-grass and great hairy willowherb being especially prominent (fig 4.3). From this point south-west to the infilled section towards the bend is one of the most impenetrable sections of the entire canal.

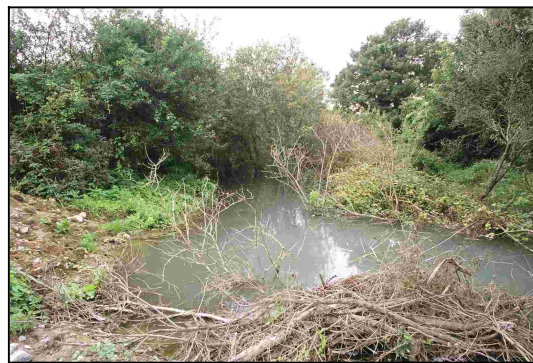
Fig 4.4 Looking west along watered section 110 from just west of bend in canal.

Although it is fringed with the usual tree and shrub species, the water in the canal at Section 112 – which is sometimes wet – is eutrophic, dominated by nettle, with hardly any of the characteristic aquatic plants seen everywhere else. The reason for this becomes apparent further east, where water from the limestone quarry north of Lea Cross Roads (in S110) is being fed into it (fig 4.4). Where the track from the Church crossed the canal the latter has again been levelled for a short distance (S111), and this causes this drainage water to fill the channel. At the boundary of the quarry the canal itself is again lost, and is not seen again until some way south-east of Bergin's Bridge.

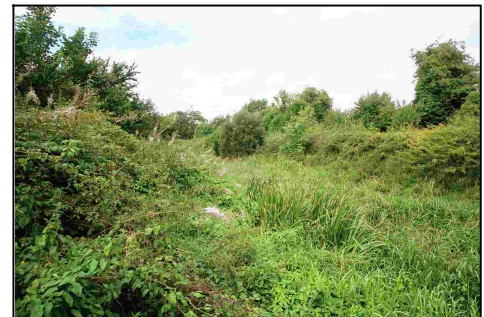
Fig 4.6 West along section 118.

The open canal comes to an end just north-east of Lock Bridge. It is greatly overgrown in Sections 116 to 118, but is wet and has the usual complement of species - reed sweet-grass, yellow flag etc (fig 4.6). The margins and banks are extensively overgrown (principally by grey willow, hazel, ash and hawthorn) and in very poor condition, and there is none of the hazel coppice or woodland ground flora seen further east towards Lea Castle. Sometimes the bank is just a strip of grassland of little interest (as it is between the canal and the barley field south of the Sewage Plant). This strip is a continuation of the lane that runs beside the canal on the north side from Lock Bridge; for the length of the lane the boundary between it and the canal is a maintained hawthorn hedge.

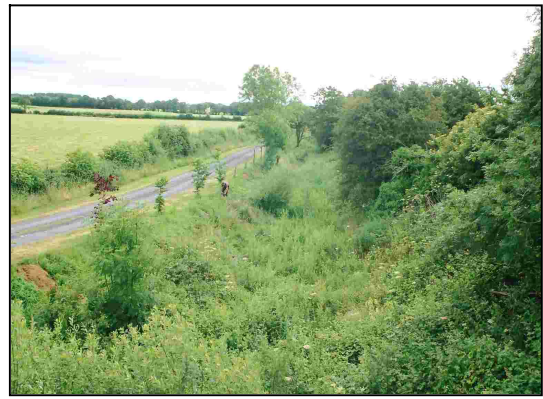
Fig 4.10 Looking east along S302 from Skeagh Bridge.

grass, meadowsweet are dominant, along with square-stemmed St. John's wort, woody nightshade and some tufted hair grass and hoary willowherb and common reed very locally; more weedy encroaching species include scutch grass, creeping buttercup, large bindweed, cleavers, hogweed, creeping bent, herb Robert, hedge parsley, bush vetch etc. There is a line of alder along either edge of the channel in places. Woody species are hawthorn, ash, blackthorn, grey willow, elder, much briar and bramble. Towards and around the bend the channel becomes quite dry. The quality of the channel vegetation becomes more impoverished to the north-east, in the direction of Tinnakill Lock.

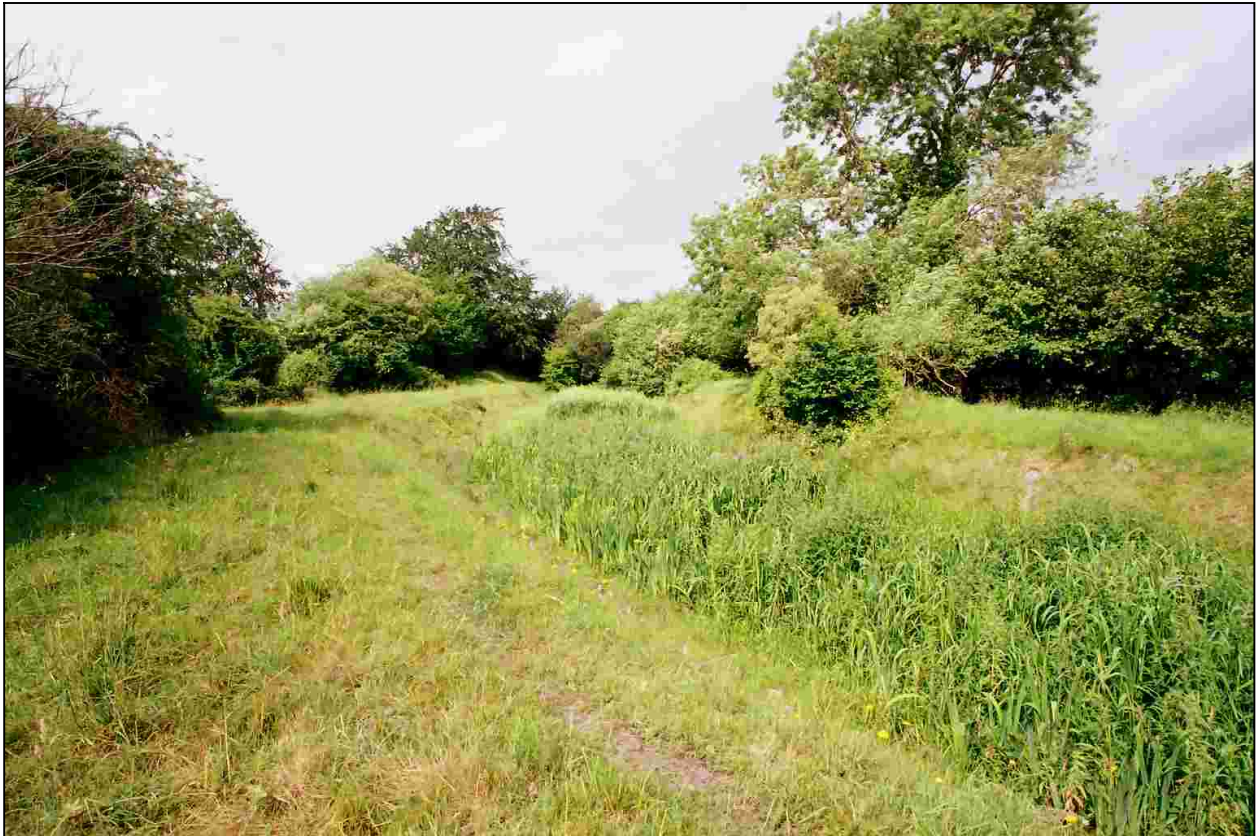
Fig 4.12 Looking south-west along S304, east of Dangans Bridge.

On the far side there is a derelict hedge between the canal and the fields (largely hazel), but there is access from the field on the east of the road to the channel (which is very unusual where the latter is open). There has been a small amount of dumping in the canal at the bend,

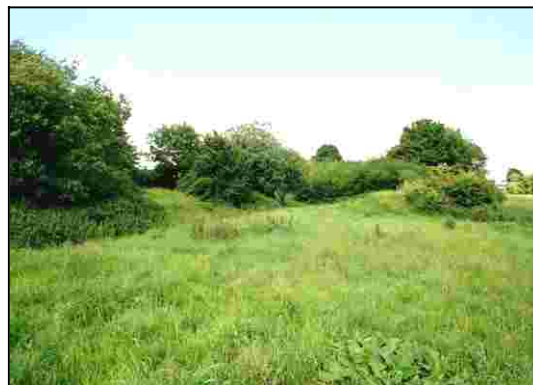
Fig 4.16 Looking east across the aqueduct.

On the bridge itself are one or two very small patches of limestone grassland, with lady's bedstraw and red fescue, meadow vetchling, wild carrot, field scabious, cinquefoil, lesser hawkbit, fairy flax, self-heal and mouse-ear chickweed (fig 4.16). The bridge is extensively overgrown with ivy, blackthorn and bramble, with tall ash, hawthorn and grey willow on the bank.

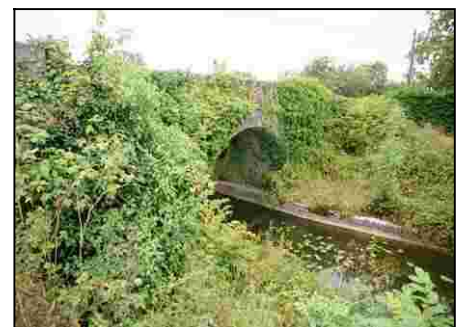
Fig 5.7 Dunne's Bridge.

Those road bridges which are still in use are particularly vulnerable to replacement because of their relatively narrow widths and humped decks. Coughlan's Bridge (F101b), Wheelahan's Bridge (F103) and Bergin's Bridge (F105), all on the main Monasterevin-Portarlinton road, are especially susceptible to replacement as they all have dogleg approaches and carry high volumes of fast-moving traffic. Although Dunne's Bridge (F002) is on a less busy road, it is likewise vulnerable because of its narrowness (fig 5.7).

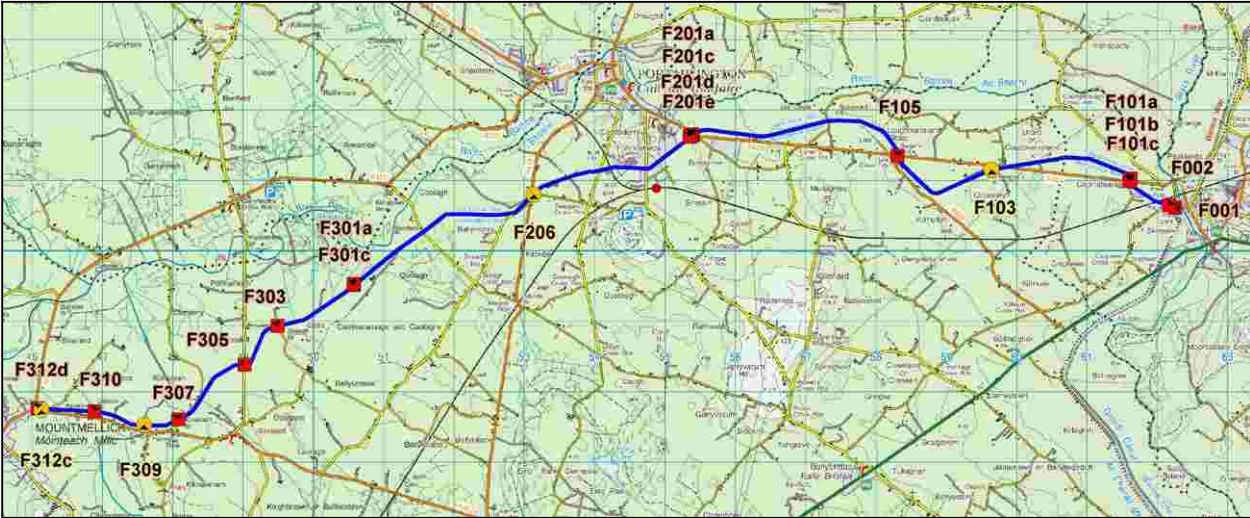
Fig 5.8 Protected canal-related sites (orange circles) and those proposed for protection (red squares).

Three of the above sites have been rated during this current survey as being of regional merit. The store at the Mountmellick terminus is regarded here as being of local rather than regional significance as most of it has been demolished.

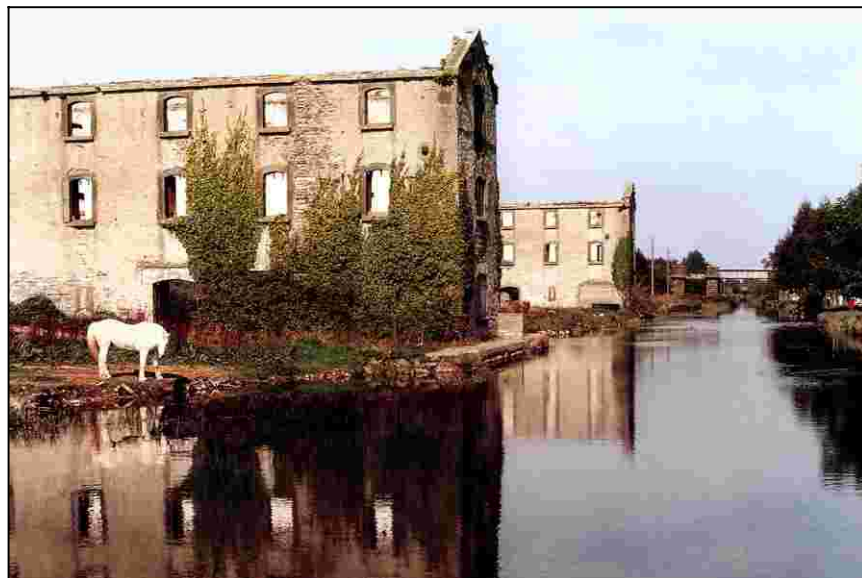
Fig 6.6 Warehouses at Monasterevin Quay (now demolished). After Kevin Dwyer (2000), *Ireland - the Inner Island: A Journey through Ireland's Waterways*, p.48 (Cork: Collins Press).

The extensive quay along the west side of the canal just above the draw bridge at Monasterevin originally had a warehouse at either end (fig 6.6). These were demolished when the area was redeveloped for housing.

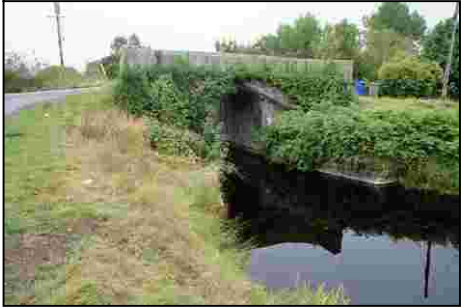
Feature F101c Coughlan's Lock House

F101c_02 22/08/2006 Lock house from north-west.

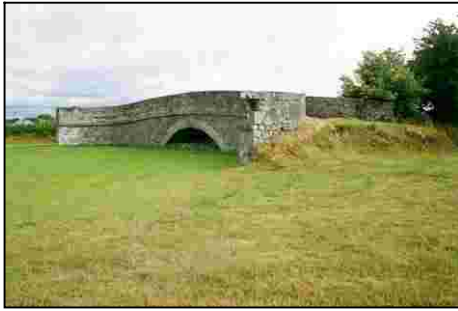
F303_02 29/06/2006 West elevation of Skeagh Bridge.

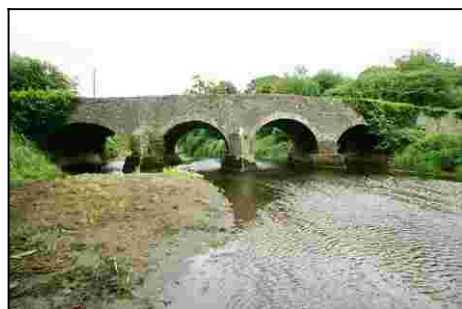
F928_02 17/06/2004 South (upstream) elevation, from left bank.
