APPROPRIATE ASSESSMENT SCREENING REPORT

UPGRADE/INSTALLATION OF BROADBAND NETWORK

DA186, Mountrath

| Client | National Broadband Ireland |
|---|--|
| Document Title | Appropriate Assessment Screening Report |

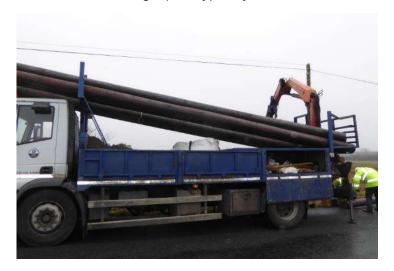
FIGURE 2. UTILITY TRUCK CARRYING UTILITY POLES AND TRUCK MOUNTED AUGER

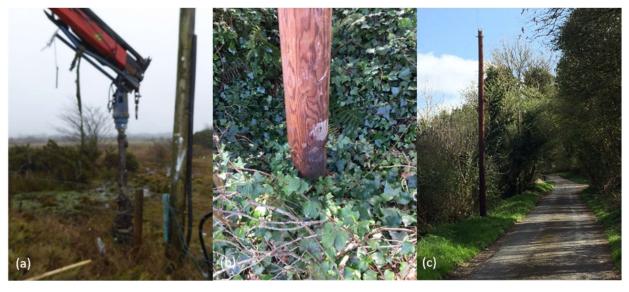
FIGURE 3. (A) UTILITY TRUCK MOUNTED AUGER EXCAVATING HOLE FOR UTILITY POLE, (B) AND (C) NEWLY INSTALLED UTILITY POLES.

- The void around the newly installed pole is backfilled with excavated material, all surplus material is placed into suitable containers and removed from site by truck for compliant waste management (maximum 115kgs per pole).

- The installation of a single pole typically takes 20 30 minutes to complete.

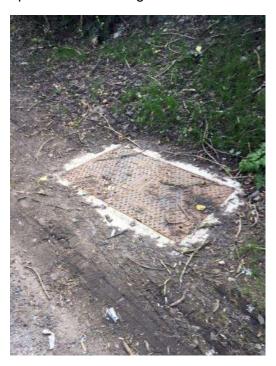
FIGURE 4. NEWLY INSTALLED CHAMBER.

- Installation of new underground chambers and fibre ducts
 - Proposed installation locations are safety checked for underground services and a temporary works area around the installation location is barriered off for reasons of safety.

- All excavation works will be undertaken in accordance with the project specific risk assessment and method statement.
 - o Once the infrastructure has been installed the open excavation will be backfilled with the previously excavated spoil and the ground made good.

- The quantity of excavated material is dependent on the length and depth of the required excavations.
 - All surplus material is placed into suitable containers and removed from site by truck for compliant waste management.

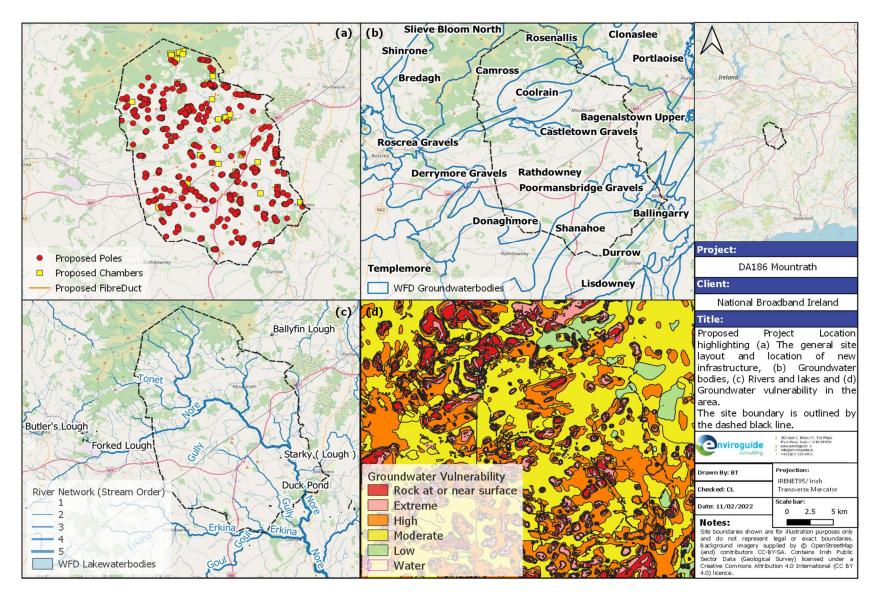
FIGURE 5. PROPOSED PROJECT LOCATION SHOWING THE LOCATION OF NEW INFRASTRUCTURE AND VARIOUS ENVIRONMENTAL FEATURES

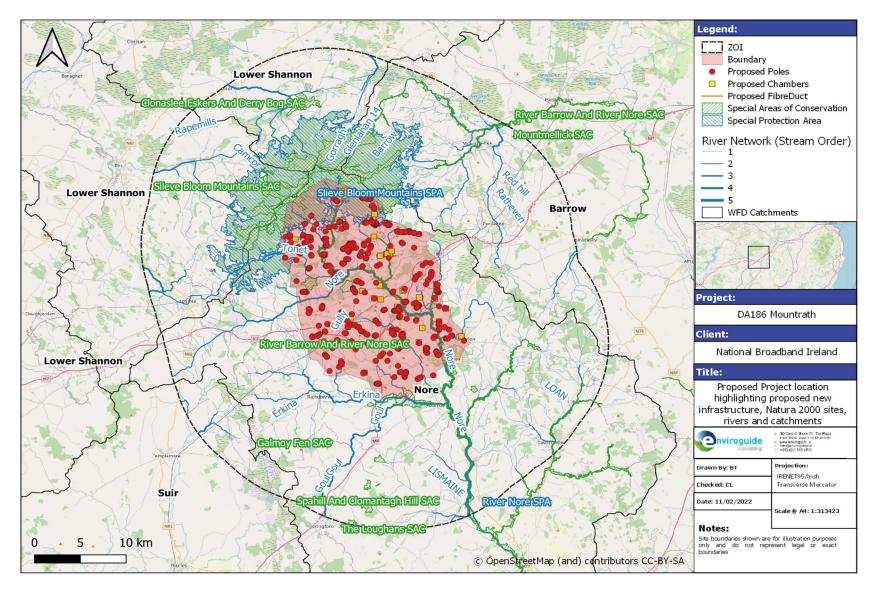
FIGURE 6 PROPOSED PROJECT LOCATION

Slieve Bloom Mountains SAC, River Barrow And River Nore SAC, Coolrain Bog SAC, Knockacoller Bog SAC, Slieve Bloom Mountains SPA and River Nore SPA are located within the project route at various points, see figure 6 below for details.

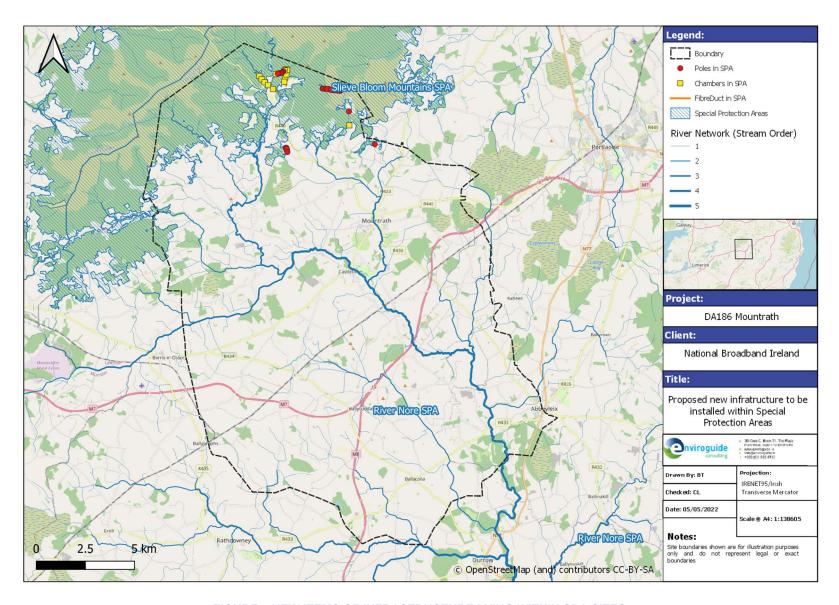
FIGURE 7 NEW ITEMS OF INFRASTRUCTURE LYING WITHIN SPA SITES

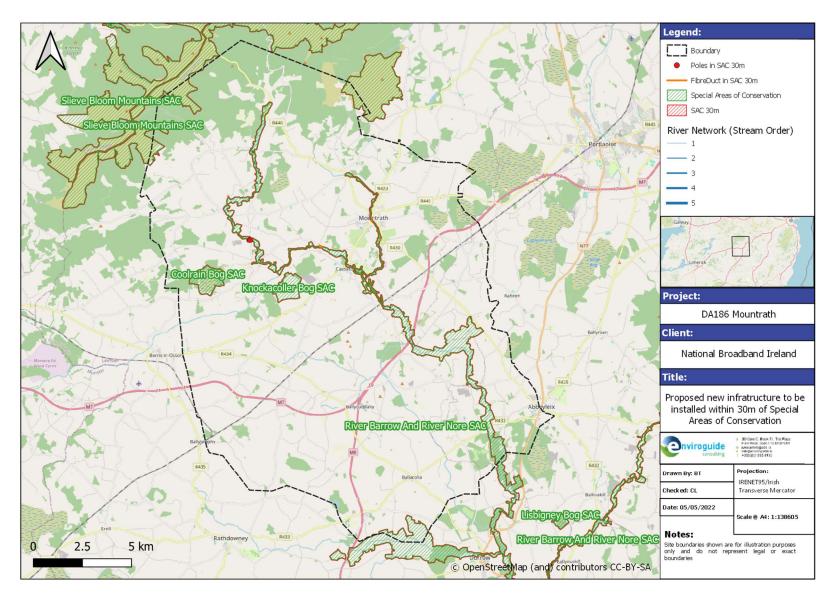
FIGURE 8 NEW INFRASTRUCTURE FEATURES WITHIN 30M OF SAC SITES.

These new items of infrastructure were assessed for potential significant effects on downstream European Sites and the species designated for them. As noted previously, a distance of 30m was chosen to account for differences in river width and mapping errors. It was concluded following desk studies that these new items of infrastructure would not result in significant effects on European Sites and the aquatic species therein for one or more of the following criteria:

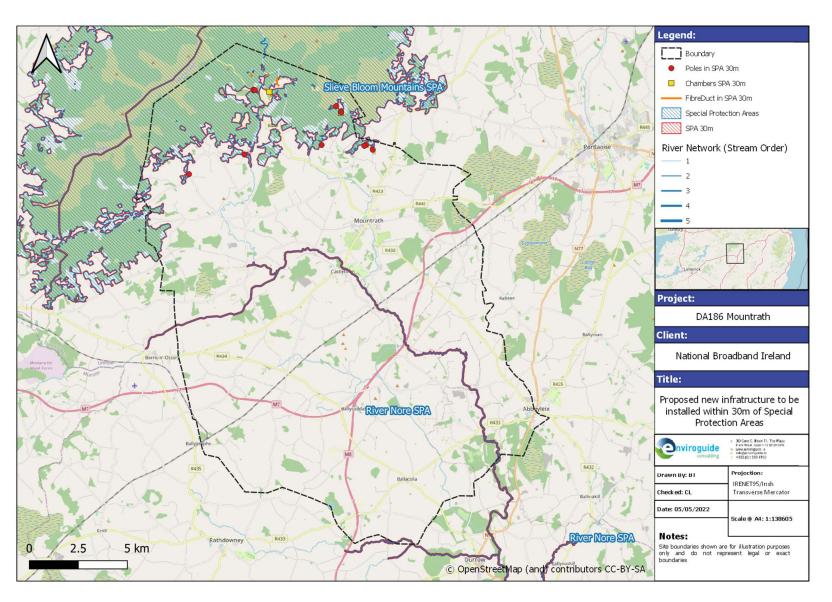
FIGURE 9 NEW INFRASTRUCTURE FEATURES WITHIN 30M OF SPA SITES.

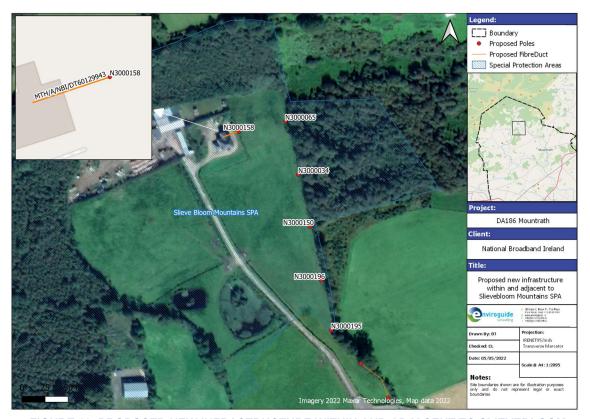
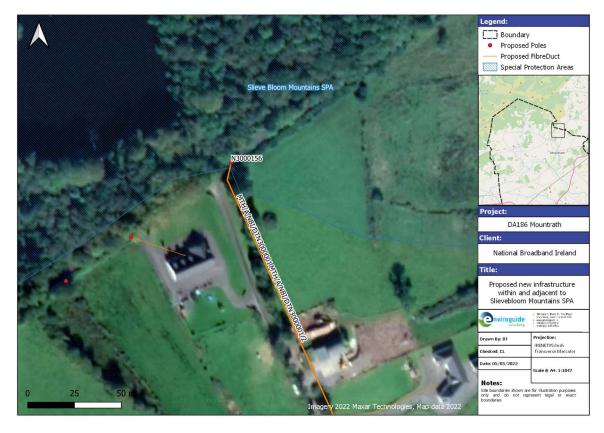
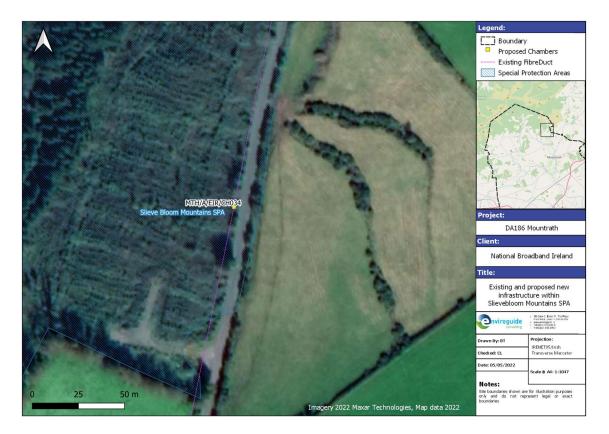
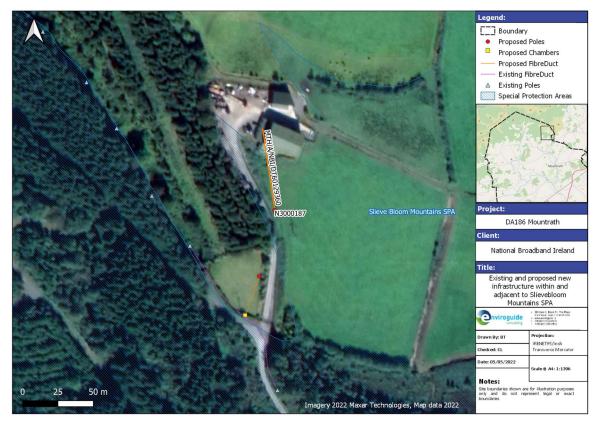
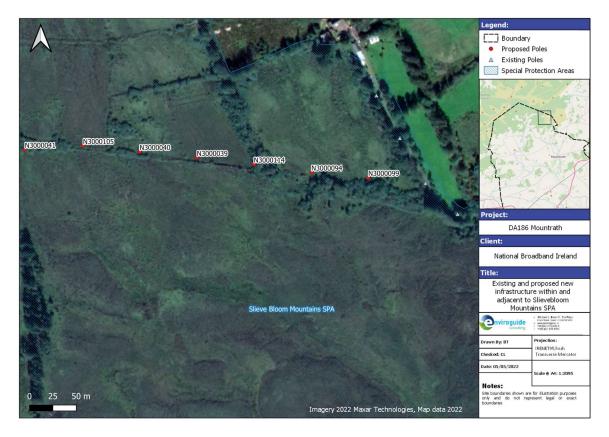
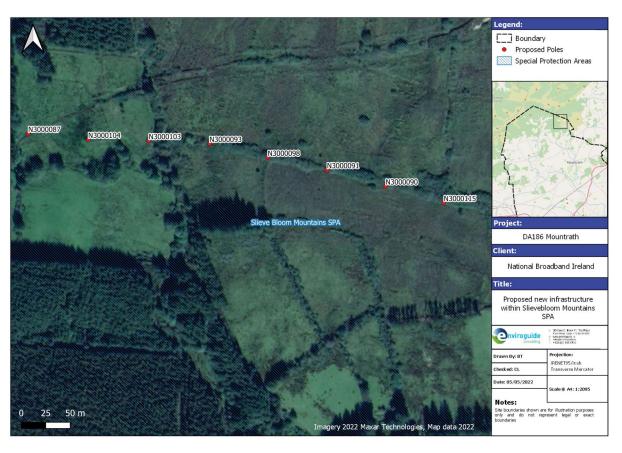
FIGURE 10 PROPOSED NEW INFRASTRUCTURE WITHIN AND ADJACENT TO SLIEVEBLOOM MOUNTAINS SPA

FIGURE 11 PROPOSED NEW INFRASTRUCTURE WITHIN AND ADJACENT TO SLIEVEBLOOM MOUNTAINS SPA

FIGURE 12 EXISTING AND PROPOSED NEW INFRASTRUCTURE WITHIN AND ADJACENT TO SLIEVEBLOOM MOUNTAINS SPA

FIGURE 13 EXISTING AND PROPOSED NEW INFRASTRUCTURE WITHIN AND ADJACENT TO SLIEVEBLOOM MOUNTAINS SPA

FIGURE 14 PROPOSED NEW INFRASTRUCTURE WITHIN AND ADJACENT TO SLIEVEBLOOM MOUNTAINS SPA

FIGURE 15 PROPOSED NEW INFRASTRUCTURE WITHIN SLIEVEBLOOM MOUNTAINS SPA

The Hen Harrier is the primary bird species associated Slievebloom Mountains SPA. The proposed new items of infrastructure were assessed for the likelihood of significant effects on the Hen Harrier within the Slievebloom Mountains SPA. In particular, the potential for installation works during the nesting season to cause disturbance and/or displacement of nesting Hen Harrier was assessed. Eric Dempsey (expert ornithologist) conducted field surveys on the 15th of April 2022 at the locations of proposed infrastructure which were identified during desk studies to pose a potential disturbance risk to Hen Harrier. It was concluded that these new items of infrastructure would not result in significant effects on Hen Harrier within Slievebloom Mountains SPA due to the following reasons.

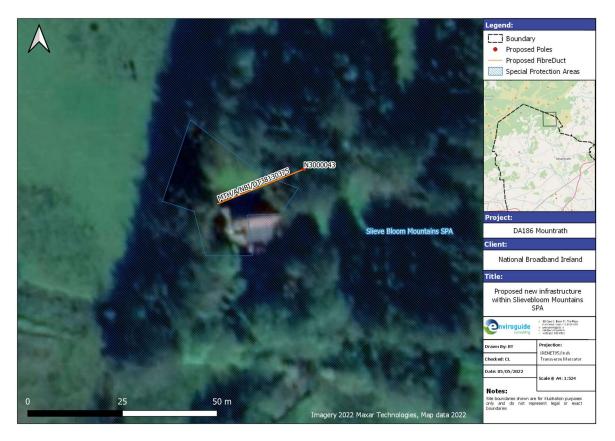
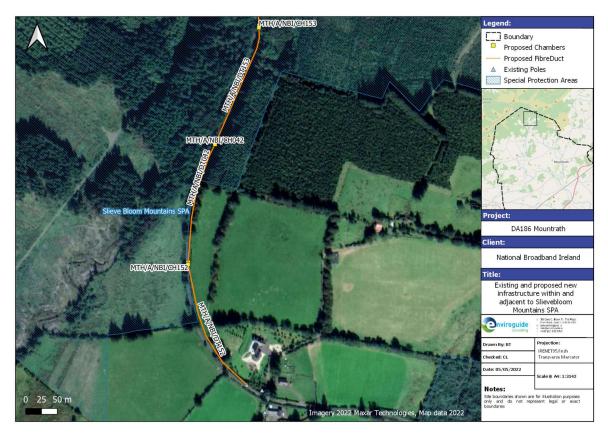
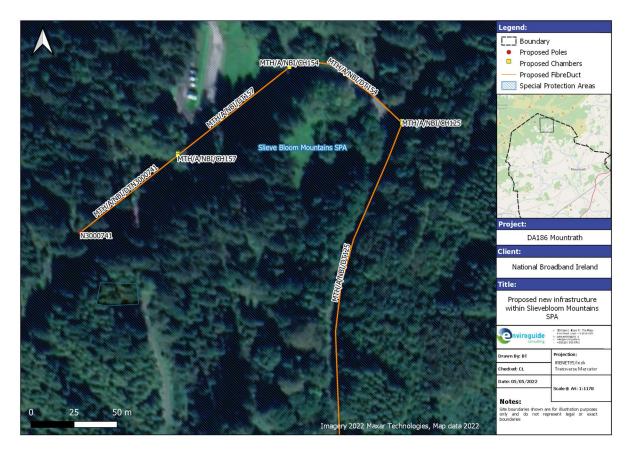
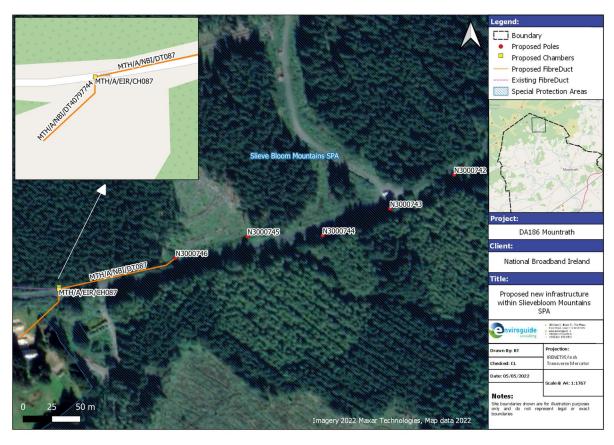
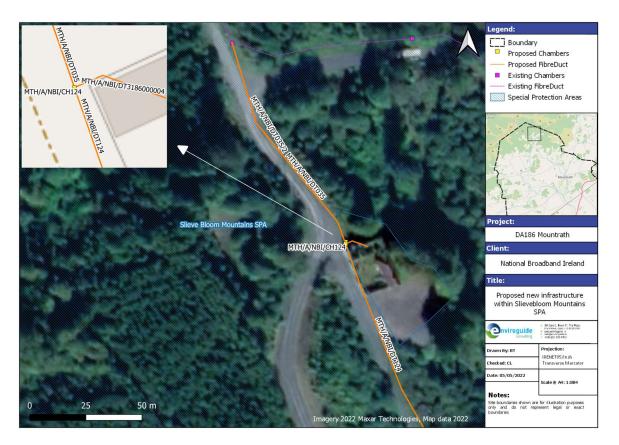
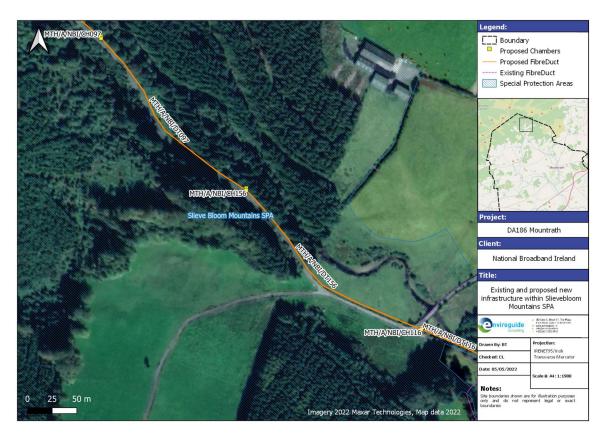
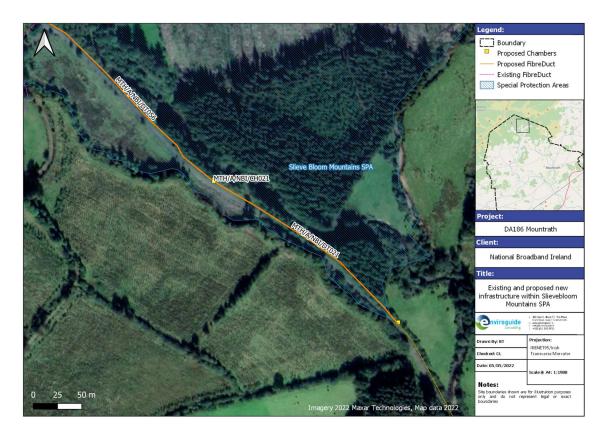
FIGURE 16 PROPOSED NEW INFRASTRUCTURE WITHIN SLIEVEBLOOM MOUNTAINS SPA

FIGURE 17 EXISTING AND PROPOSED NEW INFRASTRUCTURE WITHIN AND ADJACENT TO SLIEVEBLOOM MOUNTAINS SPA

FIGURE 18 PROPOSED NEW INFRASTRUCTURE WITHIN SLIEVEBLOOM MOUNTAINS SPA

FIGURE 19 PROPOSED NEW INFRASTRUCTURE WITHIN SLIEVEBLOOM MOUNTAINS SPA

FIGURE 20 PROPOSED NEW INFRASTRUCTURE WITHIN SLIEVEBLOOM MOUNTAINS SPA

FIGURE 21 EXISTING AND PROPOSED NEW INFRASTRUCTURE WITHIN SLIEVEBLOOM MOUNTAINS SPA

FIGURE 22 EXISTING AND PROPOSED NEW INFRASTRUCTURE WITHIN SLIEVEBLOOM MOUNTAINS SPA
