**EirGrid
Enforcement Notice
LAOIS KILKENNY
REINFORCEMENT PROJECT -
COOLNABACKY 400 kV SUBSTATION**

Report to assess the impact of the unauthorized development on the Aquifer at Coolnabacky Construction site

PROJECT: **LAOIS KILKENNY REINFORCEMENT PROJECT - COOLNABACKY SUBSTATION** **400kV**

CLIENT: **EirGrid Plc**

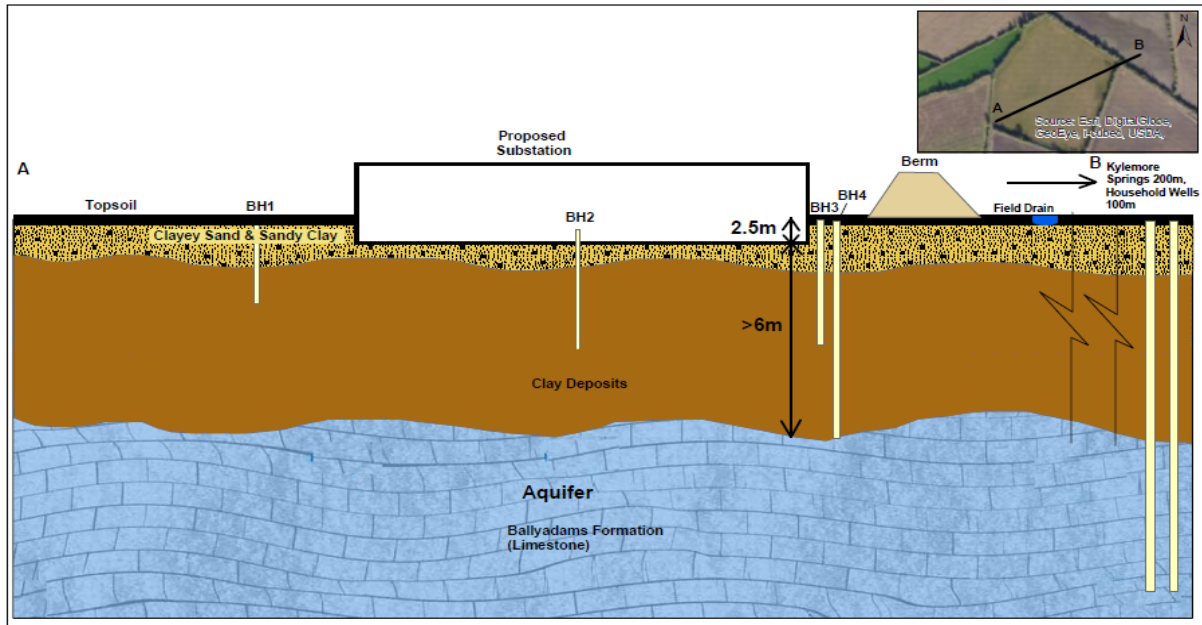
Figure 2-2 Proposed Layout - Conceptual Site Model

The Timahoe esker is a prominent feature in the area, traversing a sinuous course from east to west. Much of the deposit has been removed by gravel working. The deposits consist of clean, well sorted sands and gravels. To the south of the substation is a former sand and gravel quarry that has been reinstated and is currently in agricultural use. The site is mapped as lying within the Timahoe gravel – a Locally Important Gravel Aquifer.
