**PETRIFYING SPRING SURVEY AND ASSESSMENT
COOLNABACKY, CO. LAOIS**

December 2022

**Report produced by Denyer Ecology for:
ESB**

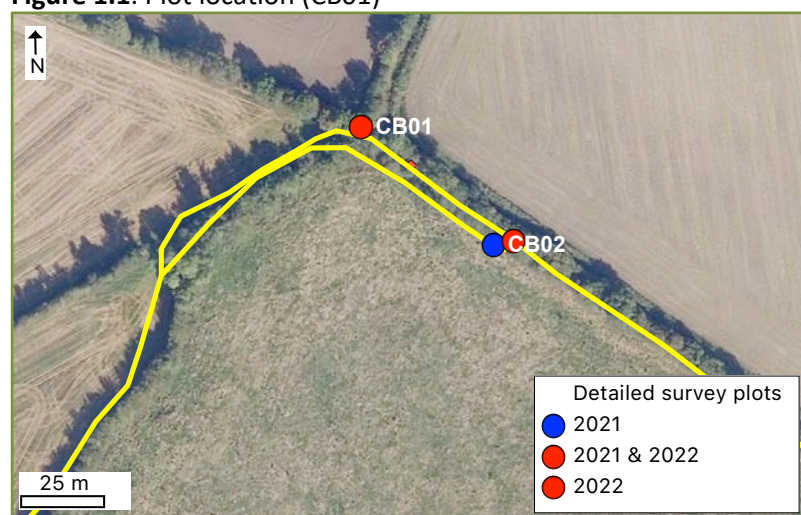
Figure 1.1. Plot location (CB01)

The plot (CB01) is located in the NW of the site, just upstream of where several streams join and flow to the SE along the northern boundary of the site.

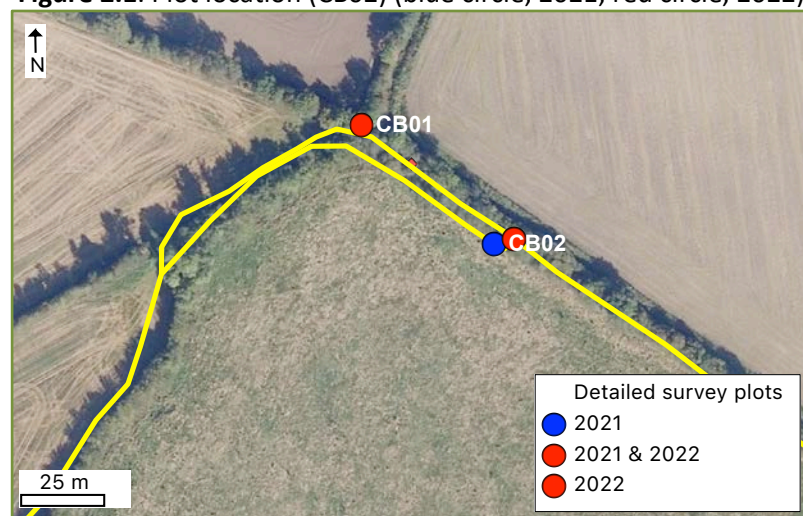
Figure 2.1. Plot location (CB02) (blue circle, 2021; red circle, 2022)

The plot (CB02) is located in the NW of the site. In 2021 it was located just upstream of where two streams join. In 2022, the plot was moved to the location where the streams join.
