Photographic Survey + Drawings

Vacant Structure to be Demolished

Junction of Derry Road and N77

Durrow, Co. Laois

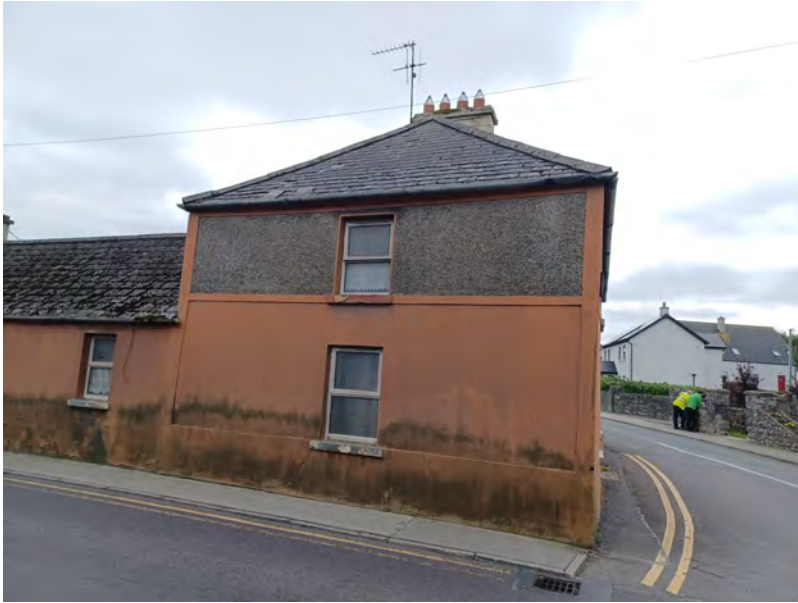
North Elevation - Derry Road, N77 Junction

Dwelling located on edge of carriageway - Lack of footpath on Derry Road and poor visibility for pedestrian and vehicles at junction.

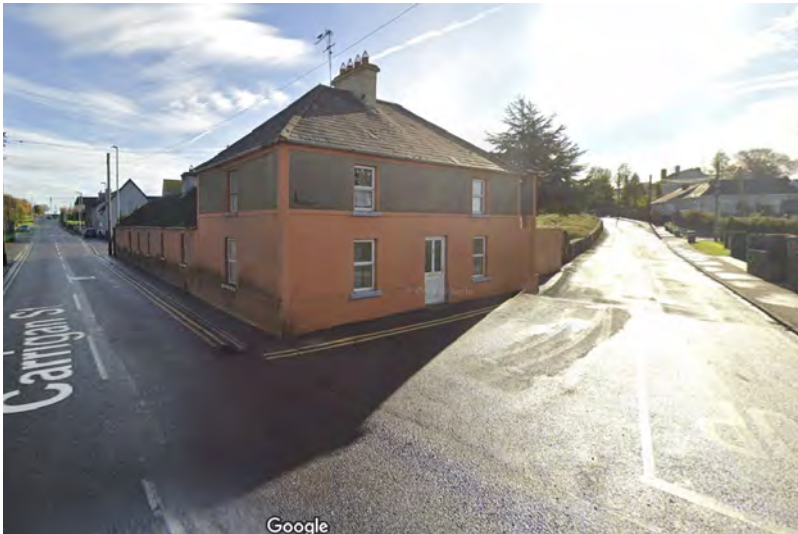
Dwelling is fully detached. It does not form part of any street terrace or group of structures
