Engineering and Major Projects,
One Dublin Airport Central, Dublin Airport,
Cloghran, Co. Dublin, K67 XF72, Ireland
Phone +353 1 703 8000

Re: 400/110 kV substation at Coolnabacky
Laois Kilkenny Electricity Reinforcement Project – ABP Reg. Ref. VA0015

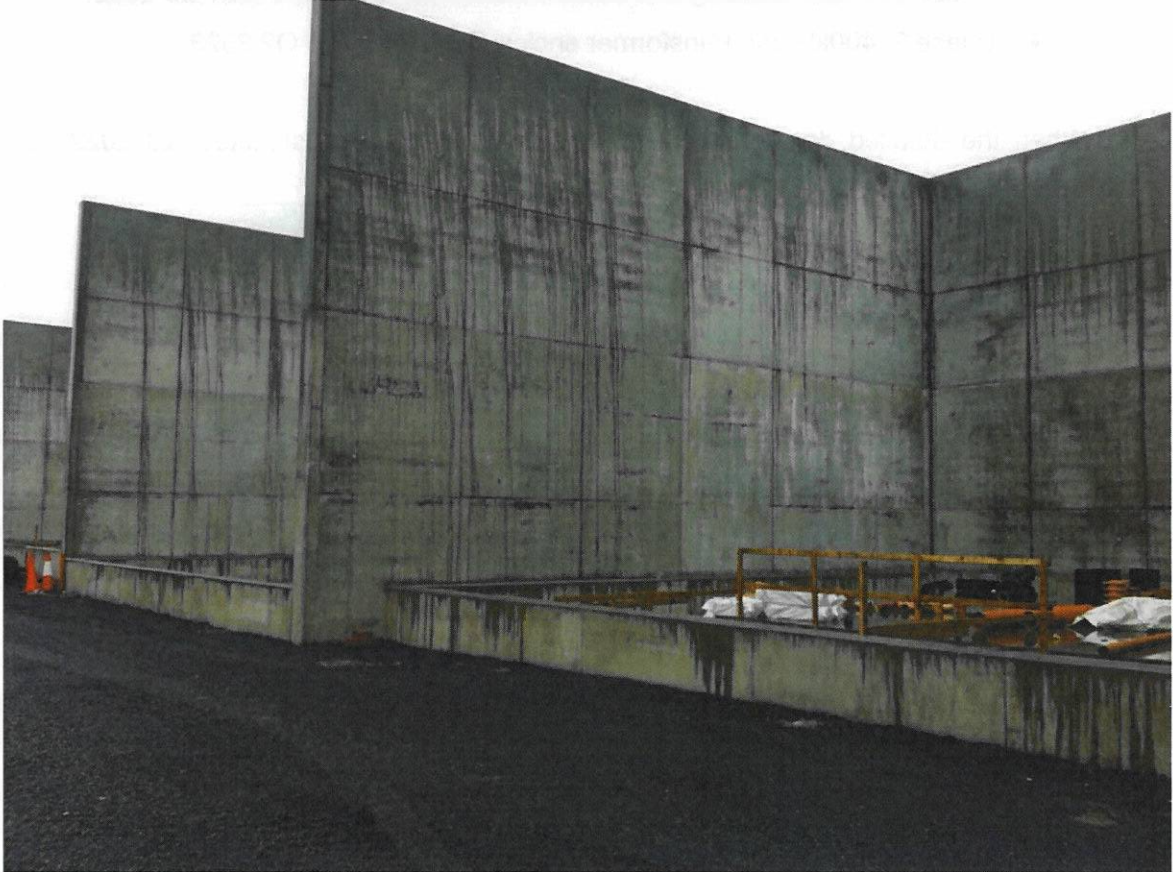
Figure 2.18 Typical walled enclosures for transformers and shunt reactors

The installation also includes enclosures for 2 no. 400/110 kV, 500 MVA transformers and 2 no. shunt reactors. These will be positioned in bunded enclosures between the two steel framed buildings and adjacent to the 400 kV GIS building. The enclosures will be plan area 25m x 10m each for transformers and plan area 14m x 10m each for shunt reactors. Both will be surrounded on three sides by fire walls approximately 10m high of reinforced concrete construction. There is no additional level of complexity in the construction of these bunds and walls due to the electrical equipment that they will house; the construction methodology is approached in the same manner as the building foundations in Section 2.6.1.1.4. Plans, sections and elevations of this enclosure can be referenced on drawing PE610-D002- 003-012.

- *In the Construction Phase, bund integrity tests will be undertaken by a suitably qualified Engineer to confirm the integrity of the bund as constructed,*
- *In the Operational Phase documented weekly inspections of the Bunds and the Class 1 Retention Interceptor will be undertaken, with additional inspections provided following heavy rainfall.*
- *In the Operational Phase a maintenance programme will be submitted to the Council for the Class I Retention Interceptor.*

- Bunds are tested before commissioning.
- All transformers are remotely monitored, on a 24/7 and alarmed for abnormal conditions including changes in oil levels.
