N77
Ch 1935 LHS and 1975
RHS

Temporary Traffic Management
to enable works on N77 Portlaoise

Type of TTM:

Static - One Way System with
inbound lane closed at Glenside

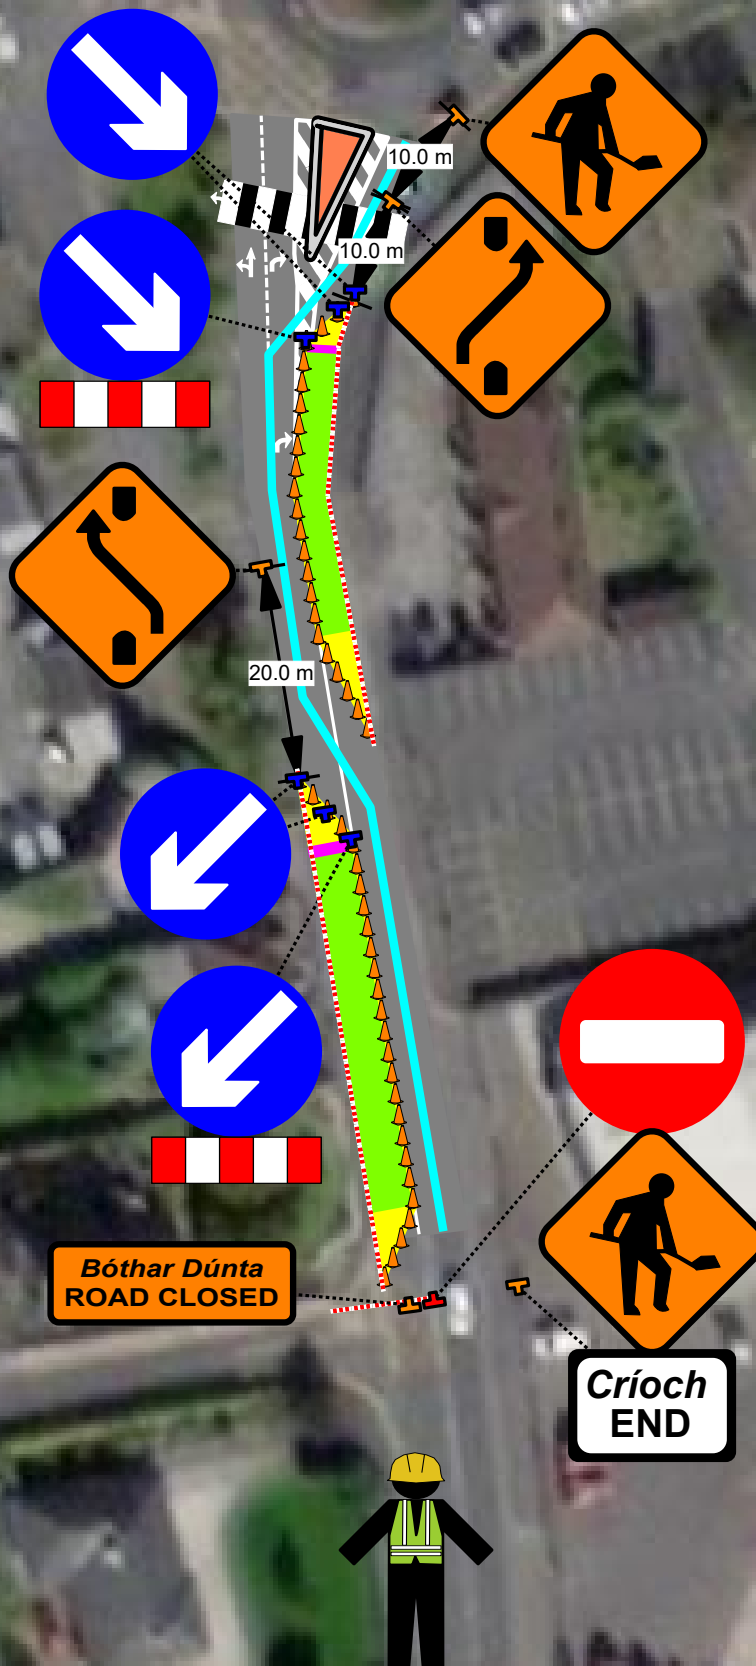
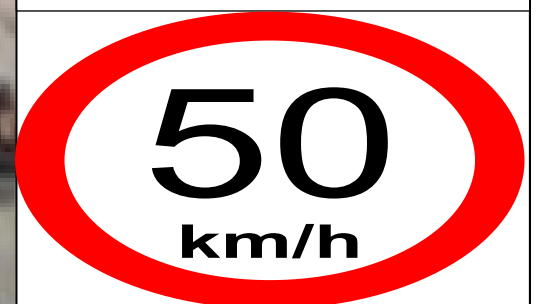
**Marshal to direct merging
traffic onto N77 One Way
System**
