Photographic Survey + Drawings

Vacant Structure to be Demolished

Junction of Derry Road and N77

Durrow, Co. Laois

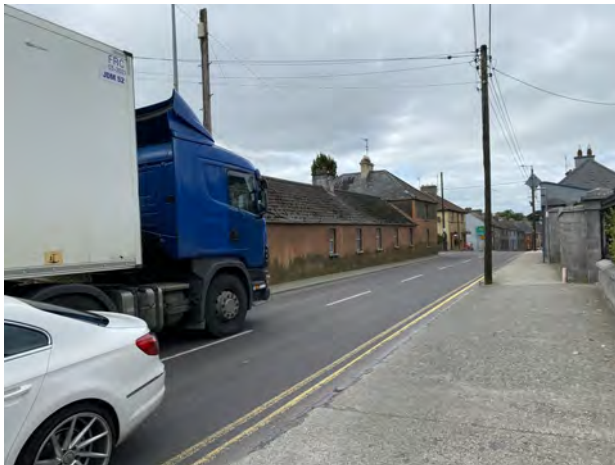
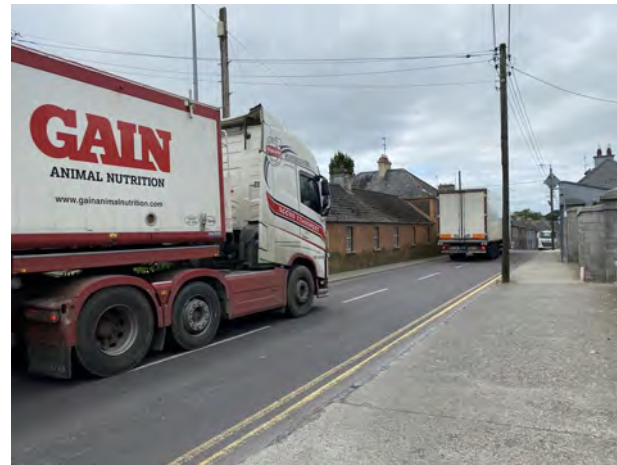
Constant flow of heavy traffic passing very close to the structure

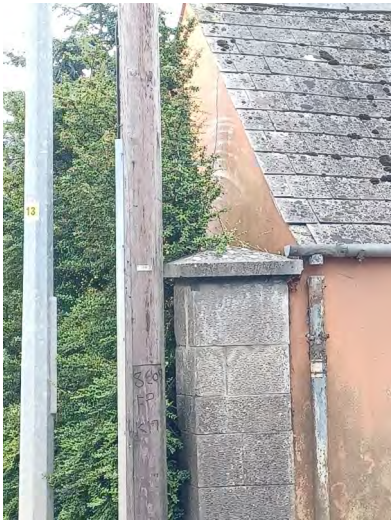
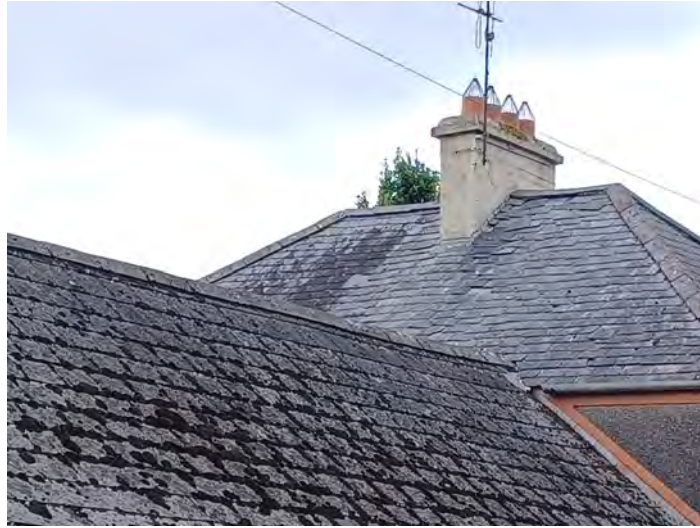
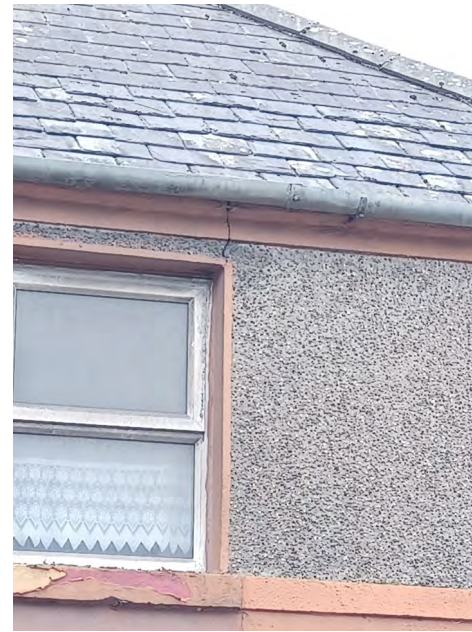
North Elevation - details

Stone pillar at boundary to be set back form road carriageway

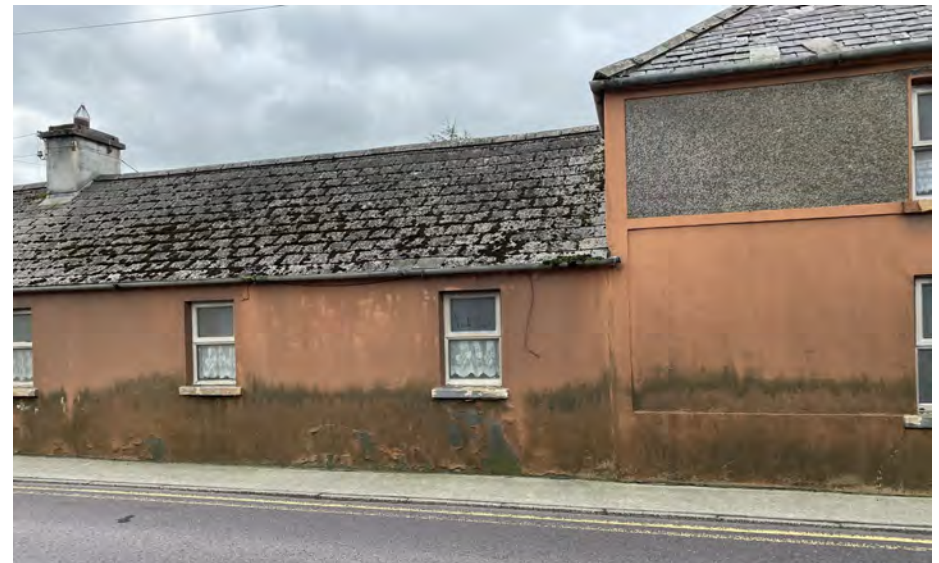
Dwelling location is very close to carriageway and does not allow for sufficient footpath width.

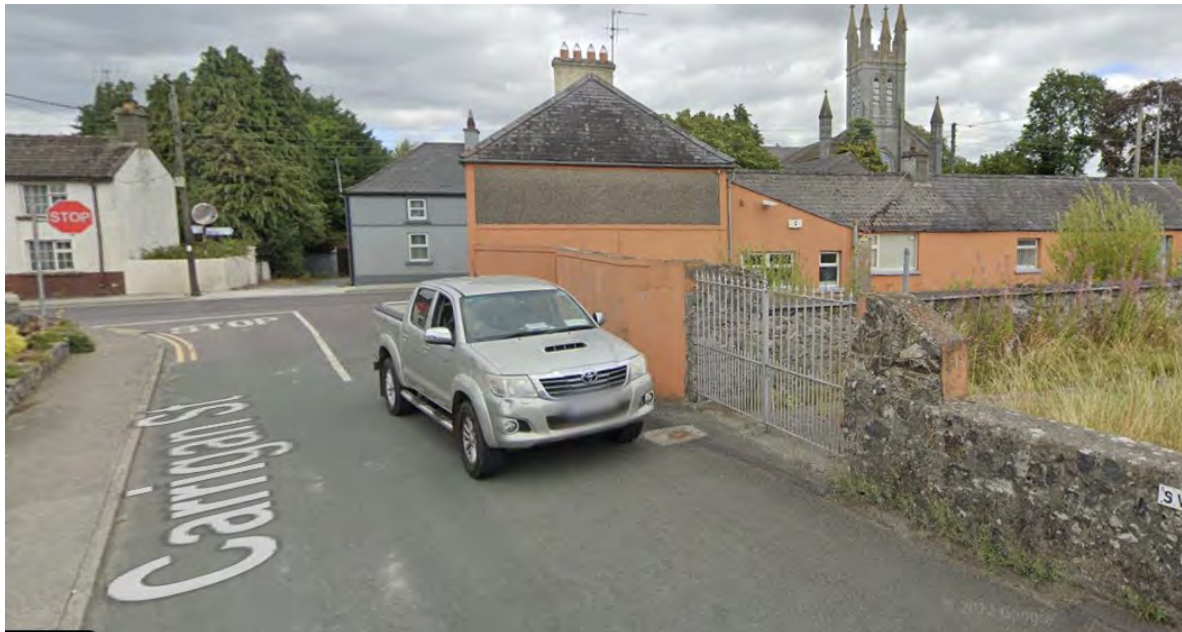
Dwelling location is very close to carriageway and does not allow for footpath width. Dangerous access to dwelling
